# A New Fire Hazard for MR Imaging Systems: Blankets—Case Report<sup>1</sup>

In this report, a case of fire in a positron emission tomography (PET)/magnetic resonance (MR) imaging system due to blanket combustion is discussed. Manufacturing companies routinely use copper fibers for blanket fabrication, and these fibers may remain within the blanket hem. By folding a blanket with these copper fibers within an MR imaging system, one can create an electrical current loop with a major risk of local excessive heating, burn injury, and fire. This hazard applies to all MR imaging systems. Hybrid PET/MR imaging systems may be particularly vulnerable to this situation, because blankets are commonly used for fluorodeoxyglucose PET to maintain a normal body temperature and to avoid fluorodeoxyglucose uptake in brown adipose tissue.

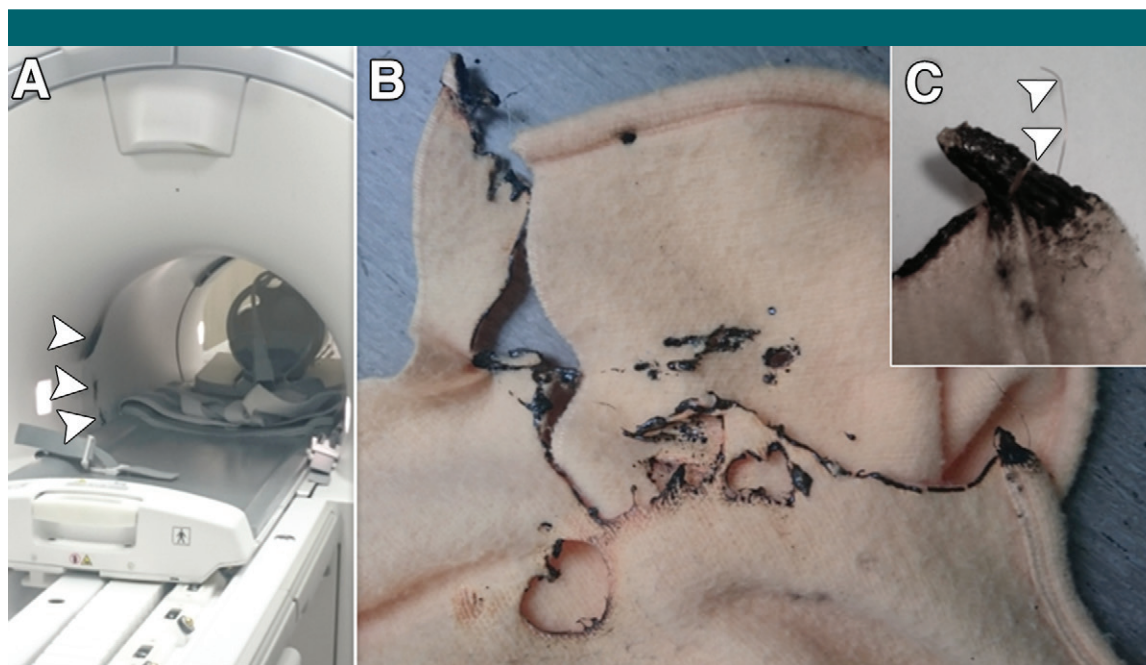
The patient had no skin lesions because she did not have any direct contact with the blanket. The antenna and the inner shell of the PET/MR imaging unit were deformed and covered with soot (Fig. A). Careful inspection of the blanket revealed the presence of a metallic fiber (Fig. B and C). Material safety investigation revealed that these copper fibers were used by the blanket manufacturer during the automatic process of blanket cutting and remained within the blanket hem. Noticeably, this technique does not appear to be specific to our manufacturer and was also used by other companies. Systematic inspection of older blankets at our hospital did not reveal the presence of copper fibers because this technique of production was recently implemented. The manufacturer was informed and modified the production line so that copper fibers were not used anymore. Radiology technicians and radiologists at the hospital were informed of the incident and were asked to stop using blankets inside MR imaging units. An

Images show traces of smoke inside the, A, 3.0-T PET/MR imaging unit (arrowheads) related to, B, the combustion of a blanket due to the presence of, C, a small copper filament (arrowheads).

isolate the patient's body from the RF coils. During fluorodeoxyglucose PET imaging, blankets are routinely used to maintain a normal body temperature, thus avoiding hypothermia-related uptake of fluorodeoxyglucose in brown adipose tissue, which may induce artifactual hypometabolism of the brain (7). Noticeably, this incident occurred in our PET/MR imaging system after 10 months of use and 881 unremarkable examinations with a similar procedure. Hence, the creation of an electrical loop in the blanket requires that the blanket folding has a specific orientation, creating an almost closed loop that likely did not occur during previous examinations. The incident was not noticed until the end of the PET/MR imaging acquisition because the blanket was smoldering without flames, and also because the patient happened to have chronic loss of smell and did not notice a burnt odor in the room. This incident could have had dramatic consequences if the patient had not been protected by the 50-cm-long restraining strap between her and the blanket.

To conclude, we have shown that the use of a blanket containing copper fibers within an MR imaging unit may present a major fire hazard because of the potential for creating electrical current loops. When isolating the patient from RF coils, disposable linens should be preferred to blankets unless the absence of metallic fiber can be assessed.
