Modelling of wear defects under Anti Vibration Bars in U-bend for the Eddy Current inspection of Steam Generator tube

Audrey Vigneron¹, Edouard Demaldent¹, Jean-Marc Decitre²,
Thierry Sollier²

Abstract

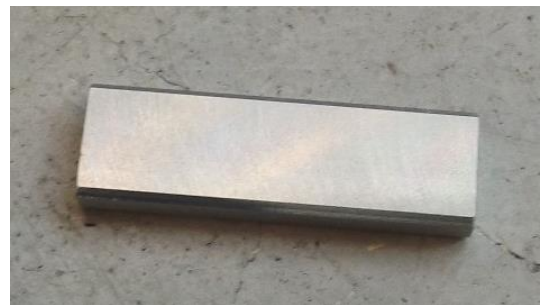
Figure 4: Representative sample of an AVB in Inconel 600.

To facilitate the movement of the probe, a puller/pusher system is employed, and the resulting EC signals are acquired using an impedance-meter. A dedicated test bench securely holds the tubes to be inspected and positions a representative sample of an anti-vibration bar. The AVB is constructed from Inconel 600, as depicted in Figure 4, with the specific dimensions provided in Figure 5. The position of the AVB in relation to the tube is adjustable: a micrometric table enables precise adjustment of the distance between the sample and the external wall of the tube, while a rotating table allows for angular placement of the AVB with respect to the tube's axis, as illustrated in Figure 6.

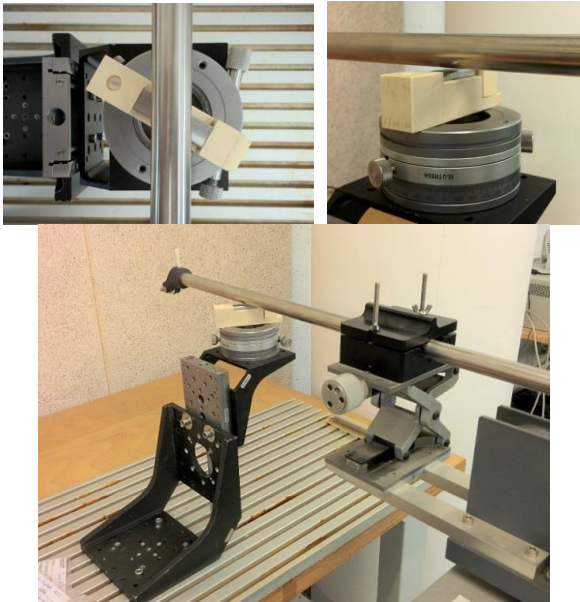
Figure 6: Experimental bench for positioning of the AVB near to the tube inspected.

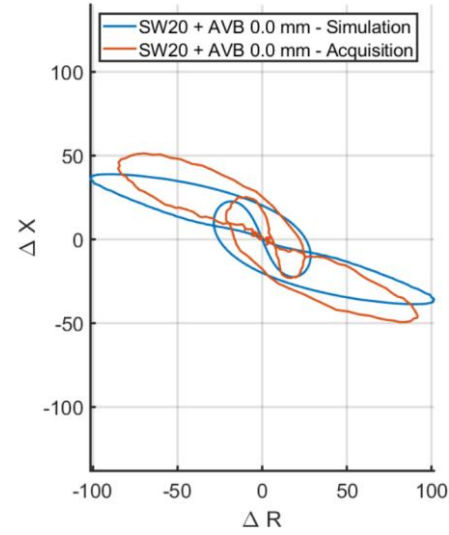
Figure 10: Experimental comparison for straight wear and AVB placed at different distance from the external tube wall, the calibration defect is the 4Ø1.

Figure 10 exhibits a strong agreement between the simulated and acquired signals, the amplitude difference between the model and experimental acquisitions ranging from 6% to 9%, and a phase difference of 6° to 8° when calibrated on the through holes. Similarly, as observed in previous comparisons, Table 7 and Table 8 indicate a reduced difference when calibrated on an external defect, specifically the EG40.
