# MONITORING OF A FULL-SCALE WING FATIGUE TEST

*National Aerospace Laboratory NLR, Voorsterweg 31, 8316 PR Marknesse, The Netherlands*

## ABSTRACT

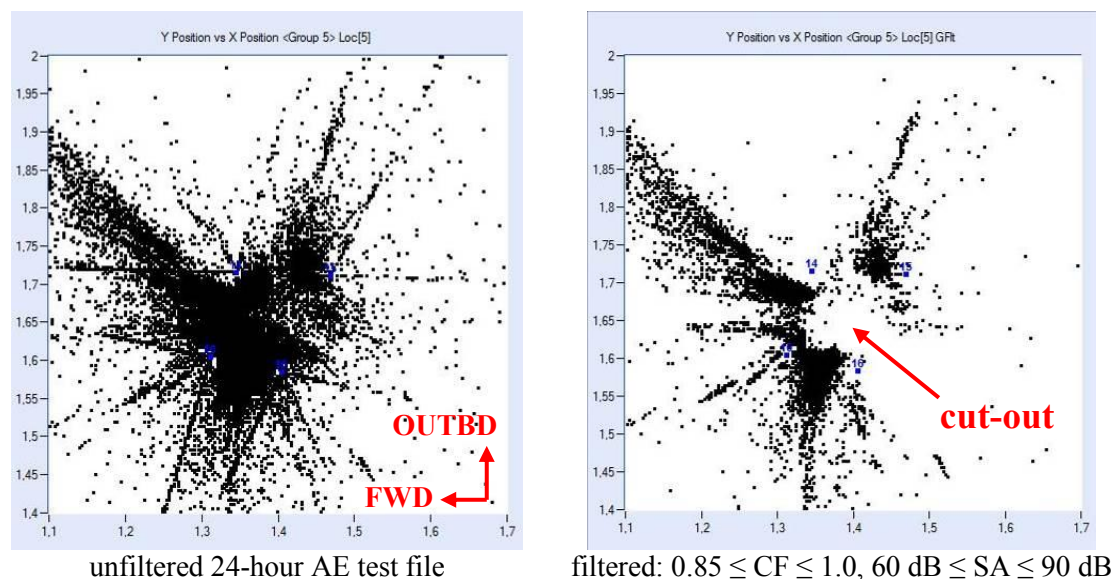
Figure 6: AE event location plots for a cut-out area on the upper wing skin. No cracks in the structure yet

AE measurements during the test were done continuously but, for practical and safety reasons, the recording was done in subsequent software files with duration of 24 hours. During the test a lot of AE activity combined with high amplitudes of the hits (up to 100 dB) was observed for all five AE groups. Figure 6 (left) gives an example for the AE event registration for sensor group 5, one of the cut-out areas on the upper wing skin (Fig. 1) in a test phase when there were no fatigue cracks in the structure yet. There is a lot of AE activity (155,917 events) and there are straight lines of AE events visible that are most certainly spurious event indications.

The influence of the changes in the AE source Location Setup module and the implementation of graphical filters is illustrated in Figure 6 (right) for the same 24-hour test file of the cut-out area on the upper wing skin. The difference between the two plots is striking and the straight lines of spurious event indications have disappeared. Furthermore, the contour of the cut-out between the four sensors is now clearly visible. However, the number of events in the location plots is still considerable (28,538 events) and the question remained whether the location plots yield relevant information about fatigue crack initiation and growth. Therefore, the AE data were further analysed for cases with confirmed crack history.

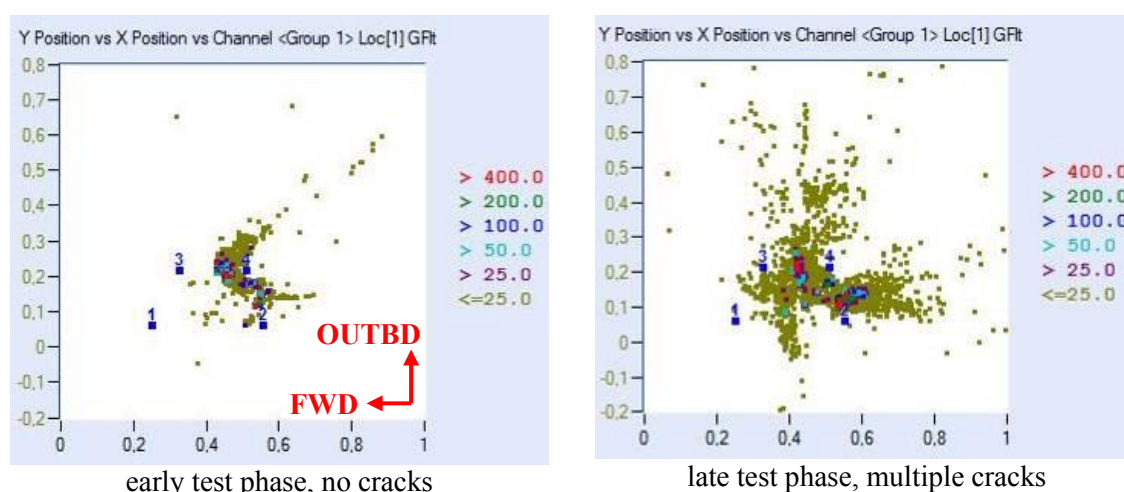
Figure 7: AE event location plots for the WAF area on the lower wing skin (AE sensors 1-4)

For both cut-out areas on the upper wing skin fatigue cracks developed during the fatigue test. However, the AE event location plots for 24-hour data files in a test phase when fatigue cracks definitively had initiated in the structure (crack length larger than 2 mm) did not differ significantly from the plots with no cracks present, for example Figure 6 (right). On the other hand, for the WAF area on the lower wing skin differences were observed, see Figure 7. The differences in the AE event location plots at different test phases, however, could not be reliably related to the location and initiation time of the fatigue cracks detected with NDI.
