# Innovative Investigations in a Prestressed Concrete Bridge

## INNOVATIVE INVESTIGATIONS IN A PRESTRESSED CONCRETE BRIDGE

In France most of prestressed concrete box-girder bridges are the object of reinforcements these last years per addition of prestressing tendons in most cases following classical complementary investigations carried out within the framework of project of repair. An innovating investigation was realized on a motorway viaduct close to Lyon in May 2013: strain gauges will be positioned on four steel tendons of prestressed right to significant cracks of the box-girder, cracks also instrumented by displacement sensors. Indeed, risks of overstretching in the tendons are expected under road traffic. A first relation will be established between the overstretchings evaluated from the measurements of the gauges and the openings of cracks from the displacement sensors. Moreover, measurements of temperature gradients were also carried out to distinguish solicitations from traffic loads and temperature effects. All these measurements are realized from a new Wi-Fi platform called PEGASE developed by IFSTTAR and the society A3IP. Finally, a fatigue analysis has been carried

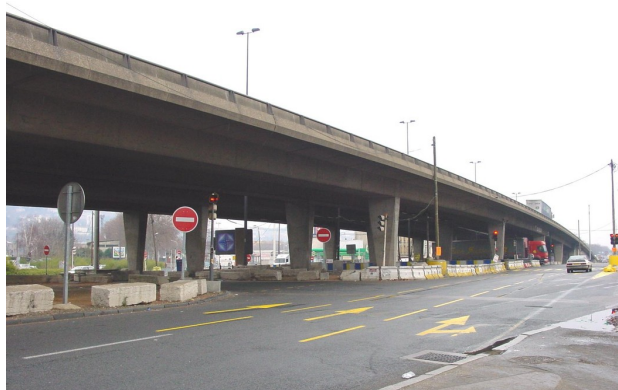
Figure 1: Overview of the Pasteur Viaduct

The Pasteur Viaduct built in 1967 is a straight bridge composed of two independent and parallel decks, each with a total length of 178.30 m. Each deck has 6 spans, respectively 21.0, 30.0, 37.5, 37.5, 30.0 and 21.0 meters (Figure 1). The decks have a width of 13.10 m off ledges and slopes of

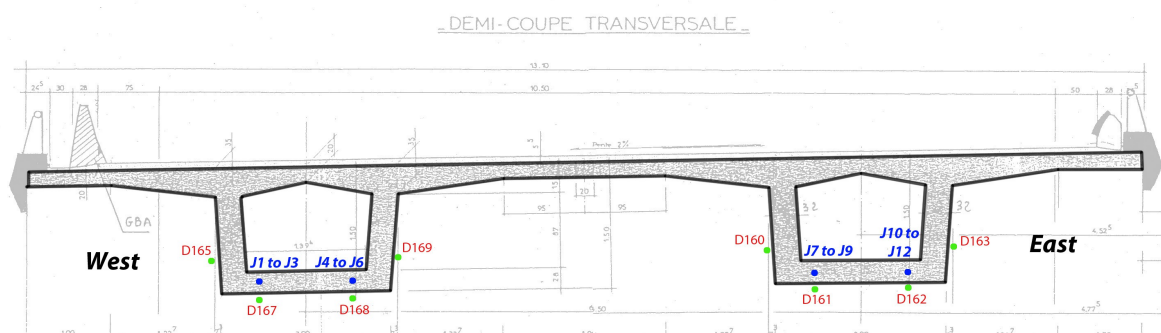
Figure 2: Cross section of one deck of the Pasteur Viaduct and position of main sensors (strain gauges and displacement sensors)

glued on two wires of one tendon and the third one on a wire of the second tendon. Gauges J1 to J6 are placed in the lower slab under right lane (heavy traffic load, gauges J7 to J12 under the left one).

Moreover, four displacement sensors are positioned in each section around the cracked section with a range of  $\pm 2.5$  mm (two outside lower slab, one outside by web of the box-girder).

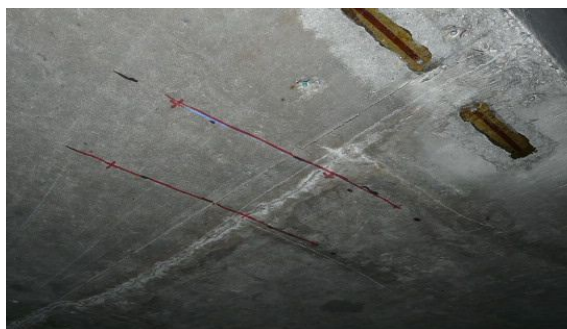
Figure 3: Transverse crack and marking of tendons in the lower slab

In each section, two tendons were identified in the lower slab by radar method [4]. Moreover, this non-destructive test enables to determine the depth of cables. A main result is that tendons are higher in the webs than as expected from construction plans. This is a good reason of the existence of these cracks (Figure 3).

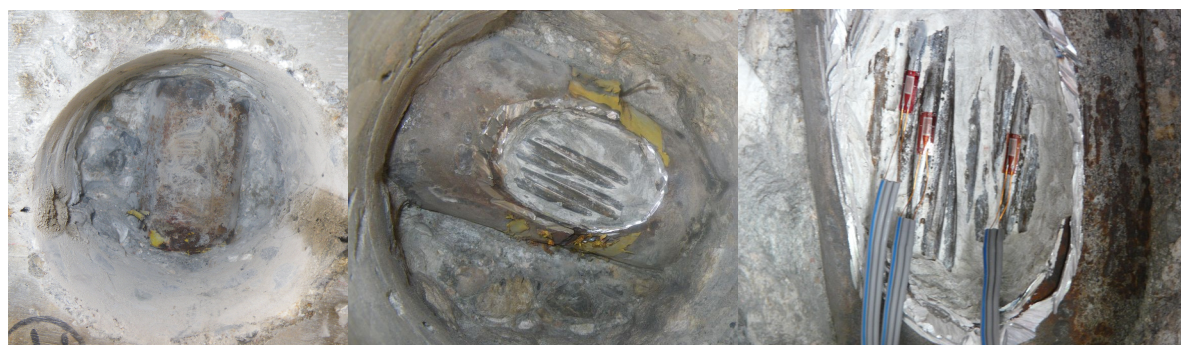
Figure 4: Window and protective steel duct of prestressing; Opening of the steel duct and elimination of cement grout around wires; Gluing of strain gauges on wires

Then, windows were made gradually and carefully not to degrade the strand. Figure 4 shows the successive steps of the creation of a window. Firstly the steel duct of prestressing is reached, then cut. The protective cement grout is eliminated delicately. The last step is the gluing of strain gauges on wires. For each of the four instrumented tendons, three strain gauges (gauge prewired FLA-3-11-3LT type TML) were glued. In each case, two tendons were visible. Two gauges were

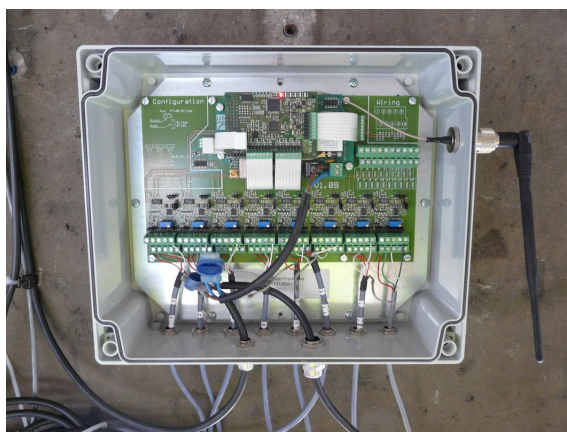
Figure 5: Wireless platform PEGASE for temperature sensors

The acquisition system for strain gauges and temperature sensors shown on Figure 5 is the wireless platform called PEGASE developed by IFSTTAR (the French Institute of Science and technology for transport, development and networks, formerly the French Laboratoire des Ponts et Chaussées).

The acquisition frequency of 5 Hz for measurements under traffic load and dynamic influence's lines. It is lowered to 1 Hz static influence's lines.

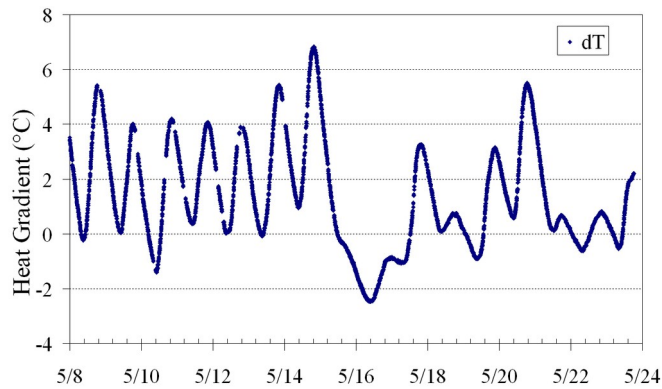
Figure 6: Monitoring of temperature gradient during may 2013

Figure 6 shows the monitoring of temperature gradient of the Pasteur Viaduct in may 2013 according to the total height of the box-girder. It varies between  $-2^{\circ}\text{C}$  and  $+7^{\circ}\text{C}$ . In the first modelling of the bridge, the temperature gradient was not taken into account. Yet it is not insignificant in the dimensioning in the bridge. Besides since 1975 in France this solicitation has been taken into account in a current project:  $+12^{\circ}\text{C}$  according to Eurocodes 1 EN 1991-1-5 [6, 7, 8].

Measurements also show that the temperature gradient is maximum in the evening around 9 PM and minimal in the morning around 9 AM.

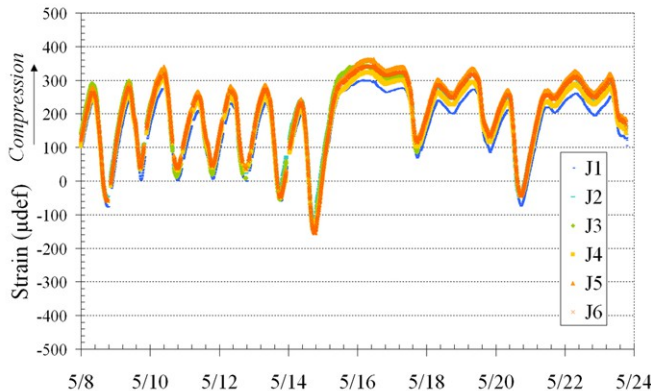
Figure 7: Average strain in tendons under slow lane (west box-girder)

Figures 7 and 8 show the results of the average and the maximum amplitudes of strain in tendons under slow lane. The results in stress (MPa) can be deduced with a Young's modulus  $E = 190,000$  MPa.

Average strain is very sensitive to temperature gradient. Tension effort in cables are maximum when heat gradient is high.

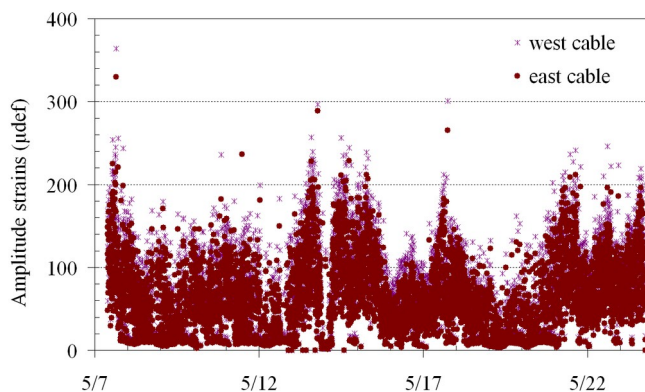
Figure 8: Maximum amplitude of strain in tendons under slow lane (west box-girder).

The level of strain amplitude under slow lane with the heaviest loads. Strain results are between 200 and 360  $\mu$ def (or around 70 MPa).

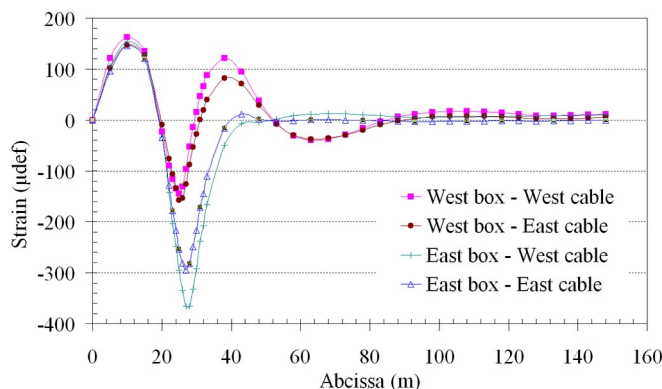
Figure 9: Influence’s line under static load. Measures of tendon’s strain.

The convoy consists of three trucks, each one on a lane (4 axles, 30 tons). Figure 9 shows measurements of strains in tendon under the static load as a function of its position on the structure. Table 3 sums up main maximum results of static load.

The behaviour of the two box-girders is very different. The east one is deformed more than the west one (+ 57%). This difference can be explained by a larger concrete interface degradation with prestressing tendons on the west box-girder than on the east one due to the presence of lorries on the west box-girder.
