OPERATIONAL MODAL ANALYSIS AND WAVELET TRANSFORMATION FOR DAMAGE IDENTIFICATION IN WIND TURBINE BLADES

Martin D. Ulriksen¹, Dmitri Tcherniak², Poul H. Kirkegaard¹, Lars Damkilde¹

ABSTRACT

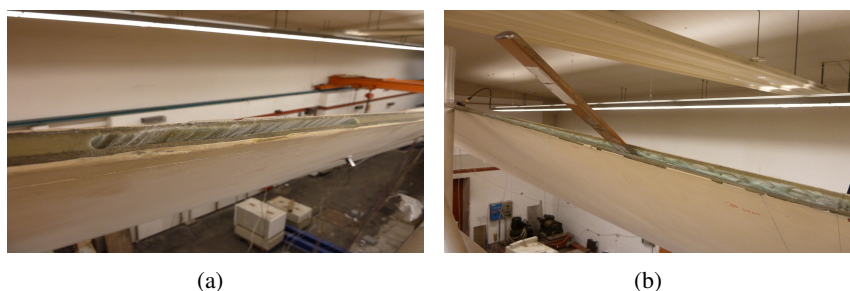
Figure 3 : Debonding introduced in the trailing edge of an SSP 34 m blade. (a) Original drilled debonding. (b) Extended debonding.

The debonding was first introduced by drilling a series of holes perpendicular to the trailing edge, such that the glue connecting the shells was removed to yield the damage depicted in Figure 3(a). Subsequently, the debonding was gradually extended using a hammer and a chisel, resulting in the 1,200 mm long debonding shown in Figure 3(b). The extended debonding was located between 18,800 mm and 20,000 mm from the blade root.
