# Structural Health Monitoring of a Smart Composite Bridge Using Guided Waves and Acoustic Emission Techniques

## STRUCTURAL HEALTH MONITORING OF A SMART COMPOSITE BRIDGE USING GUIDED WAVES AND ACOUSTIC EMISSION TECHNIQUES

This paper is dealing with the development of a structural health monitoring (SHM) system implemented on a composite footbridge during the regional project "Pays de la Loire" called DECID2. The SHM system was made out of complementary techniques: strain sensors based on optical fibers (out of concern in this present work) and ultrasonic techniques that are presented in this document. Due to the huge size of the composite bridge (20 m \* 3 m), only its most critical areas are monitored as the assembling parts and the most solicited areas. To access the structural integrity of the footbridge, two complementary monitoring strategies were presented in this paper:

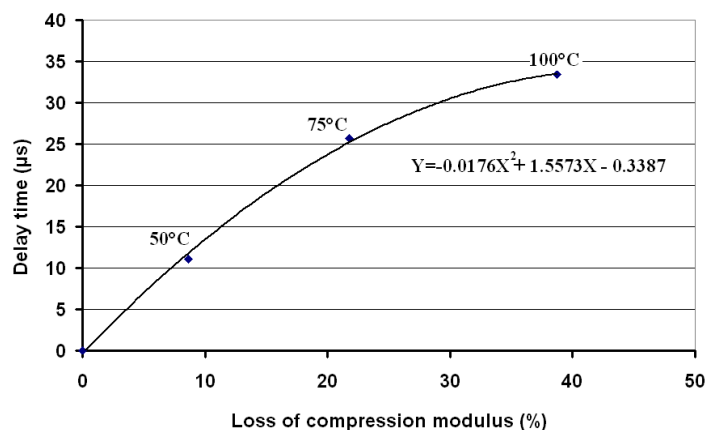
Two patches are therefore used, one as an emitter and the other as a receiver. A burst signal with a magnitude of  $10 V_{pp}$  was generated every 10 ms at a frequency of 30 kHz. For each temperature, a load test was performed up to 50kN (within the elasticity area) to calculate Young's modulus. Guided wave measurements were made at each temperature in order to determine the influence of stiffness loss on guided wave propagation. It is interesting to note (Figure 5) that the decrease of resin's stiffness due to increasing temperature, results in the increase of the arrival time of the  $A_0$  Lamb mode. For a loss of 39% of resin stiffness, a delay time of 33  $\mu$ s was measured. Thus, these experiments have confirmed the decrease of the  $A_0$  wave velocity with the reduction of the resin's stiffness.

Figure 5: Delay for the arrival time of A0 mode versus loss of resin stiffness.

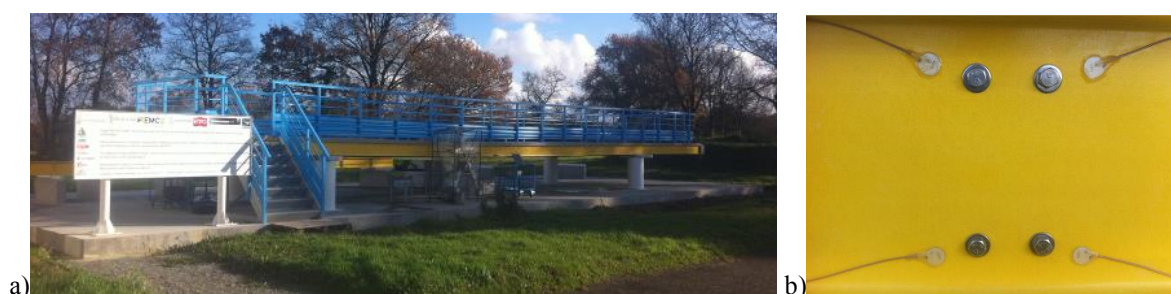
Finally, two composite footbridges were built at the EMC2 Technocampus and IFSTTAR in France to serve as demonstrators (Figure 10). They are made from pultruded composite (glass fiber/vinylester) that are provided with a structural health system in the form of embedded optical fibers and miniaturized ultrasonic sensors glued to the bars. Both active (guided waves) and passive (acoustic emission) structural health monitoring systems were installed. Active method can detect the resin stiffness degradation using guided wave and passive method (acoustic emission) can detect and locate fibres breaks. In this work, miniaturized ultrasonic sensors are developed and validated by various environmental and mechanical tests. Their ability to detect fibres breaks was

demonstrated despite a low sensitivity compared to standard AE sensors. Model prediction of  $A_0$  mode sensitivity to resin stiffness loss was validated by quantitative mechanical experiments at various temperatures. Sensors are installed at critical areas, namely the highest bend area and near bolts. The acoustic emission monitoring system is remotely controlled via an internet connection and configured to warn the supervisor by email-sending once an active damage is detected. The real time detection and location of the degradation provides safety of installation and users and will avoid catastrophic failure.

Figure 10: a) Demonstrator composite Footbridge; b) Miniatures sensors for bolt assembly monitoring.
