## QUANTITATIVE DAMAGE ASSESSMENT OF HYBRID COMPOSITE WIND TURBINE BLADES BY ENERGY BASED ACOUSTIC EMISSION SOURCE LOCATION

Dong-Jin Yoon<sup>1</sup>, Byeong-Hee Han<sup>1,2</sup>

<sup>1</sup> Center for Safety Measurement, Korea Research Institute of Standards and Science  
267 Gajeong-ro, Yuseong-gu, Daejeon, 305-340, Republic of Korea

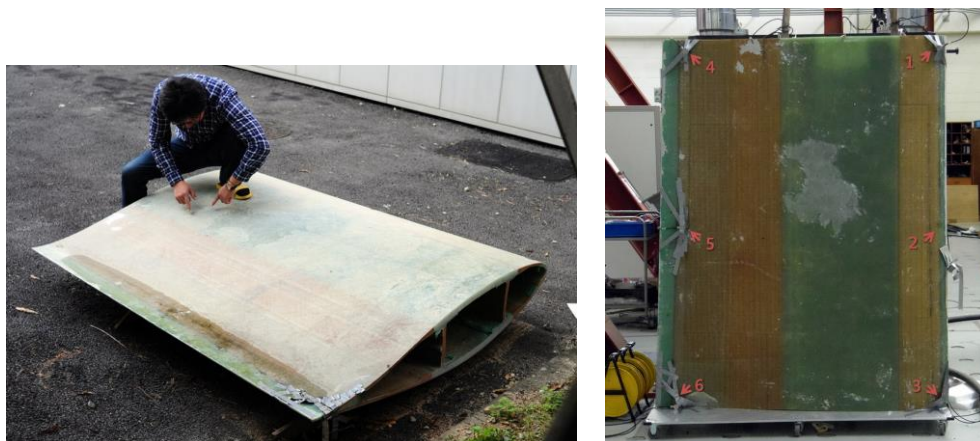
In order to assess the damages in the wind turbine blade, we have used a part of full scale blade of 3 MW in capacity. As shown in Fig. 3, this blade was specially cutted for experiments, which is 2,000 mm long in length and 1,500 mm in width. They consist of two skin plate and two vertical shear web in the middle of blade. This blade skins and shear web is made of glass fiber reinforced plastic (GFRP) and balsawood respectively.

Figure 3: Wind turbine test specimen

In this experiment, six R6I type sensors (PAC, USA) which have 60 kHz resonant frequency ranges were used, and this integrated type sensor includes a pre-amplifier inside. These six acoustic emission sensors were attached on the outside skin of blade using couplant. The position of attached sensors is shown in Figure 3. We have used two measurement system of commercial acoustic emission equipment and self-assembled high-speed digitizer. MicroSAMOS AE system (PAC, USA) was used for AE data acquisition and analysis, and also 8 channel high speed digitizer was used to acquire raw data signal for applying of new proposed source location algorithm.
