STRAIN MONITORING IN STIFFENED COMPOSITE PANELS USING EMBEDDED FIBRE OPTICAL AND STRAIN GAUGE SENSORS

Roman Růžek¹, Martin Kadlec¹, Konstantinos Tserpes², Evangelos Karachalios³

ABSTRACT

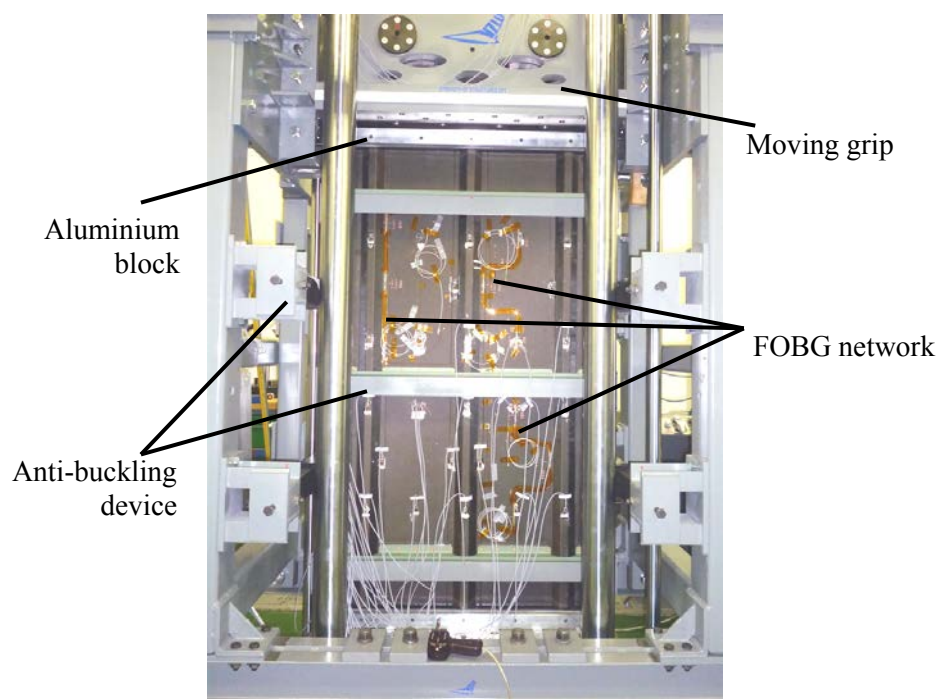
Figure 1: Panel compression test configuration in the 1 MN MTS stand

The specific loading conditions were chosen because they are highly representative for a bottom fuselage panel. Moreover, compression after impact is generally the most representative test for composite panels. The BVID and VID locations were determined so as to influence the performance of the overall panel. The external dimensions of the panel were 1650×900 mm. Each of the panels in this study contains aluminium blocks at each end to enable the introduction of accurate compressive load. A special anti-buckling frame was designed and manufactured with the aim of achieving test boundary conditions that are very similar to those in real application. The static and fatigue tests were conducted using a 1 MN MTS hydraulic frame with a TestFlex®40 control system [7]. The test arrangement of the panel in the MTS hydraulic test stand is shown in Figure 1.

At each of the three panels, nine FOBGs were mounted (Figures 1, 2, and 3) following a configuration of three sensors per line. The position of the sensors in the network in the panel is shown in Figure 3. The optical sensors were placed in the middle section of the bays as well as at the edge of the stringers foot. In Panel_1, the sensors were bonded externally. The sensors were bonded by cyanoacrylate adhesive onto the selected positions on the panel. Next, a slightly larger length of the fibre optic (including the FOBG) was covered with standard two part epoxy paste adhesive (Araldite® 2015 by HUNTSMAN) for extra protection and bonding security. In Panel_2 and Panel_3, the sensors were embedded into the structure. Embedment of the FOBG sensors during manufacturing is a tedious task because it involves many difficulties, such as the selection of ingress and egress points of the sensor data lines, the possible effect of the embedded sensors and ancillaries on the mechanical properties of the composite and the risk of sensor breakage during fabrication. The FiberSensing FOBG sensors were used in the arrays of three sensors. The wavelengths of the sensors at each array for Panel_1, Panel_2, and Panel_3 were 1526 nm, 1547 nm, and 1568 nm, respectively. Due to the intense temperature/pressure conditions occurring during curing, the primary coating of the optical fibre was polyimide with a polyimide recoating on the grating location after inscription of the FOBGs to improve the mechanical performance. The FOBG lines were embedded “bare” (without any buffer protection) so that there is direct strain transfer from the laminate to the FOBGs. Only at the position of ingress/egress points was placed a small length of buffer cable (typ. 0.4 mm in diameter - also polyimide) for extra protection of the fibre. FC/APC connectors were placed on the fibre optic cables using the standard splicing process. Figure 2 shows an example of embedded FOBG routing in a panel with the egress and ingress point definition.

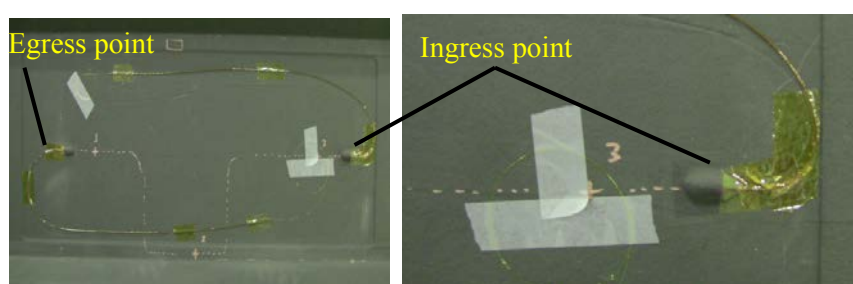
Figure 2: Embedded FOBGs routing on damaged BVID / manufacturing defects configuration (Panel_2)

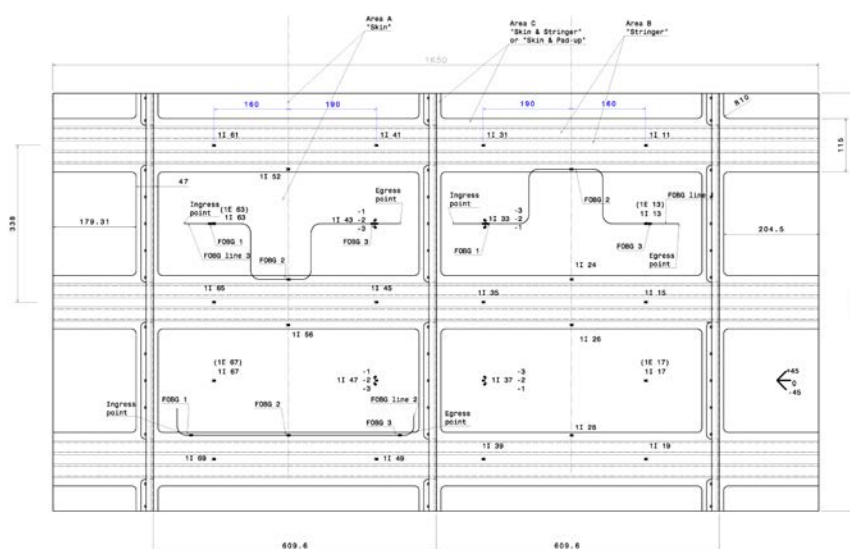
Figure 3: Definition of the locations of the strain gauges and the FOBG sensors (Panel_1)

To be able to validate the measurements given by the FOBGs, a large number of linear and rosette resistance strain gauges were mounted externally to the panels. 69 strain gauges channels were measured for each panel. The strain gauges were placed at different positions on the bays and omega stringers (at the foot and the top of stringers), as shown in Figure 3 and Figure 4.

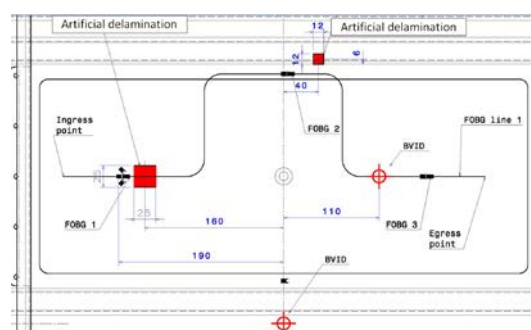
Figure 4: Definition of the locations of the FOBG sensors in line 1 of Panel_2

In Panel_1 and Panel_2, the sensors were placed at the bays of the same side with respect to the axis of the panel, while in Panel_3, the sensors were placed at anti-symmetric bays. In Panel_2, the sensors placed at the middle of the bays are very close to the artificial delamination as well as to the impact damage sites (Figure 4). Thus, they are expected to capture any phenomena developed there, due to the concentration of the initial damage, by recording the extreme values of strain. In general, the three lines of the FOBG sensors were mounted into the panels –line 1 and line 3 each contain two sensors on the bay (L1S1, L1S3, L3S1, L3S3) and one sensor on the stringer foot (L1S2, L3S2); line 2 contains three sensors on the stringer foot (L2S1, L2S2, L2S3).

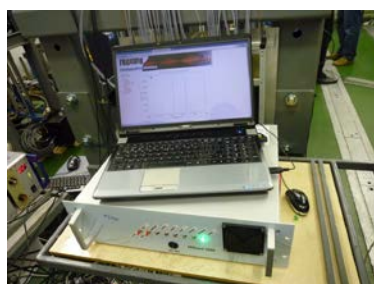
Figure 5: FOBG FBGuard measuring device and evaluation PC with FBGuard web interface

Data from the strain gauges were recorded, stored and evaluated using a BMC Messsysteme GmbH equipment [8]. The system was controlled using the NextView 4.2 data acquisition software [9]. The FBGuard (Safibra producer) 4-channel high accuracy FOBG static and dynamic measuring device [10] with the following parameters for strain measurement was used:

- Main wavelength bulk is set at $1550 \text{ nm} \pm 20 \text{ nm}$;
- Wavelength accuracy is $\leq 15 \text{ pm}$, and the wavelength resolution is $\leq 1 \text{ pm}$;
- Scan frequency (sampling) up to 300 Hz;
- Minimum channel switching delay time 10 ms; optical connector FC/APC;
- Dynamic range 20 dB; laser class (IEC 60825-1) 1.

acquired value consisted of at least 2 values for each FOBG sensor. The data processing was handled using MS Excel software. Figure 5 shows the FBGuard measuring device.

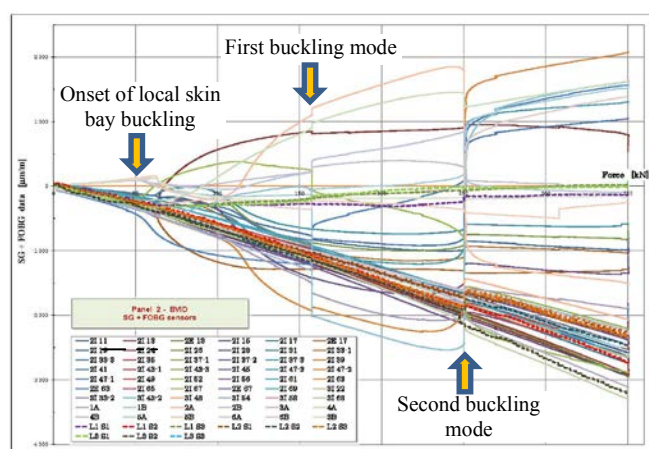
Figure 6: Comparison of FOBG (dash lines) and SG data vs. force (Panel_1)

Figure 6 shows the overview of the strain signals measured by both optical and resistance strain sensors during the static loading up to 70% of the expected Panel_1 failure load (solid lines correspond to strain gauges, and dashed lines correspond to optical sensors). Three different buckling modes in the skin bays occurred in panel_1 (at 60 kN, 160 kN and 250 kN). Figure 7 – Figure 9 show the comparison of the corresponding FOBG and SG strain signals of the sensors situated in the same areas in the panels. The data in Figure 7 represents sensors bonded onto the surface of Panel_1. The positions of the stringer sensors in Panel_1 are not located on the same stringers, but on different stringers in the same location. The sensors bonded on the stringers produced linear strain vs. force curves (left diagram) up to 92% of failure load. The loss of the foot stringer stability in the area of future failure is indicated by the nonlinearity of the signals in the final phase of loading. All of the sensors (FOBG and SG – right diagram) bonded to the skin surface are able to detect the development of the buckling waves. The same colours of the curves indicate the same skin locations of the sensors (FOBG sensors are placed into the inner side of the skin, and SG sensors are placed into the outer side of the skin). The large variation in the measurements indicates the large variation in the deformation of the areas around the locations of the sensors.

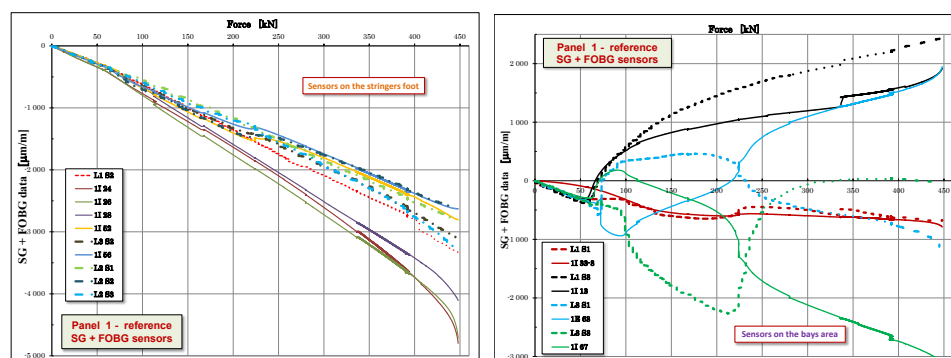
Figure 7: Comparison of FOBG (dash lines) and SG data vs. force– reference Panel_1

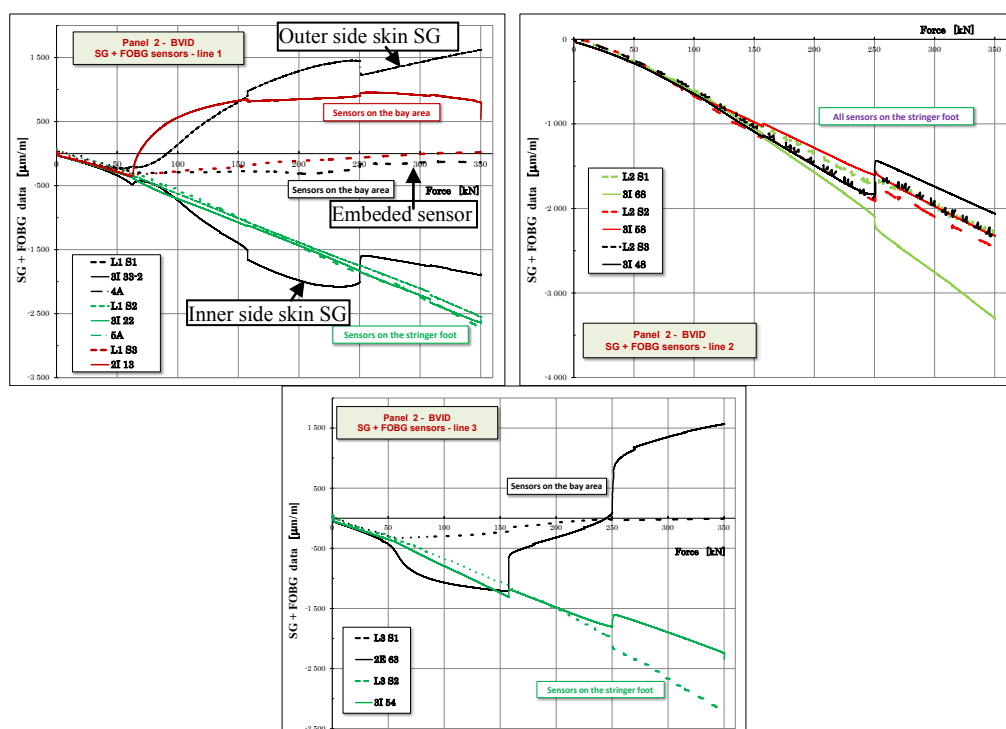
Figure 8: Comparison of FOBG (dash lines) and SG data vs. force – BVID Panel_2

Figure 8 and Figure 9 show the comparison of the corresponding bonded SGs and the embedded FOBG sensors into the structure for each individual FOBG line of Panel_2 and Panel_3, respectively (see above mentioned sensors topology description). The locations of the SGs were selected so as to have some of the locations of the SGs to coincide with the locations of the FOBGs. The same colour of the curves indicates the same locations of the sensors. The FOBG sensors data are represented by dashed lines, and the corresponding data measured using SGs are displayed by solid and dot-dash lines.

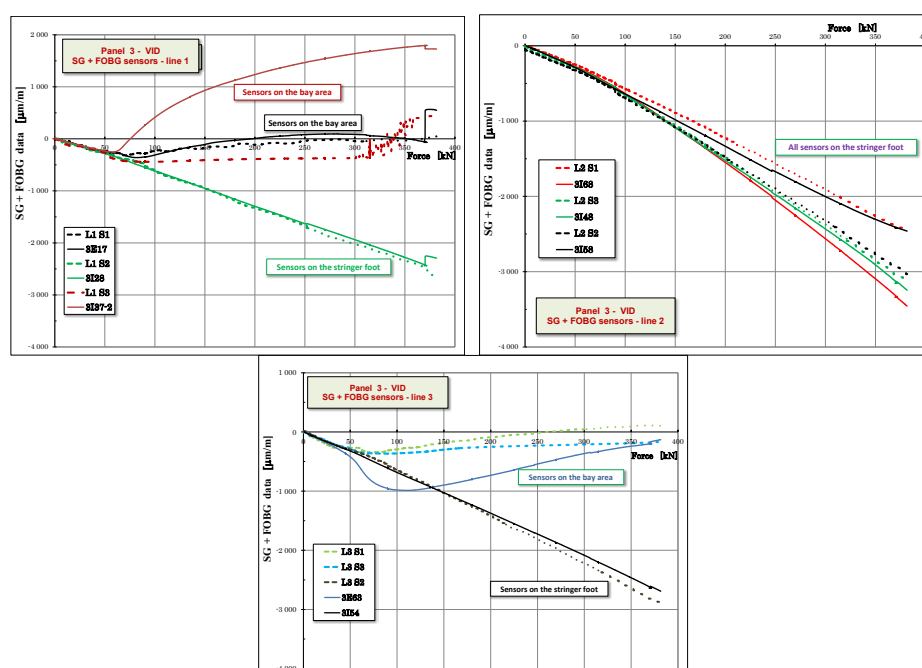
Figure 9: Comparison of FOBG (dash lines) and SG data vs. force – VID Panel_3

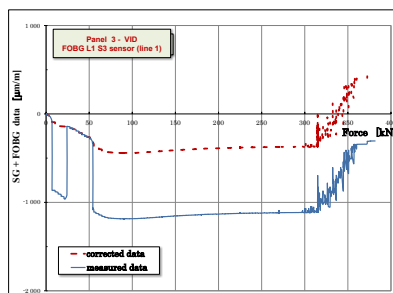
Figure 10: Modification of the FOBG data for the L1 S3 sensor – VID Panel_3

The L3S3 sensor in Panel_2 exhibited a small non-measurable peak. The fault of this sensor was most likely caused during manufacturing or the BVID creation process. The strain history of the L1S3 sensor in Panel_3 is not continuous – see Figure 10. The discontinuity in the range between 6.9 kN and 24.3 kN and the step at 54.2 kN cannot be explained by sudden deformation changes. The discontinuity was repeatedly measured, although no relevant deformations of the structure were registered. This discontinuity in the response can be considered as a rough sensor error due to the optical fibre or panel manufacturing. The rough data error can be eliminated by a constant scale (720 $\mu\text{m/m}$) subtraction, as shown in Figure 10. The low robustness of fibre optic sensors against damage and difficulties with fibre handling are important application problems.
