## USE OF DISTRIBUTED FIBER OPTIC SENSORS TO DETECT DAMAGE IN A PAVEMENT

### ABSTRACT

**KEYWORDS:** *Distributed fiber optic sensor, asphalt concrete pavement, cracks, non-destructive inspection.*

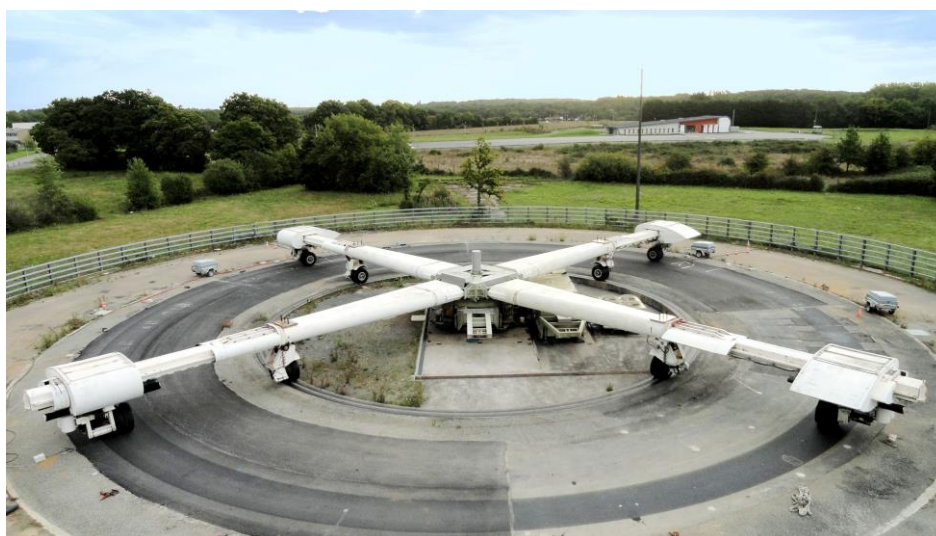
Figure 1: Accelerated pavement testing facility of IFSTTAR

The pavement fatigue carrousel of IFSTTAR (Figure 1) is a large scale circular outdoor facility, unique in Europe by its size (120 m length, 6 m width) and loading capabilities [1]:

- maximum loading speed 100 km/h,
- loading rate 1 million cycles per month,
- 4 arms which can be equipped with different wheel configurations,
- lateral wandering of the loads to reproduce real traffic.

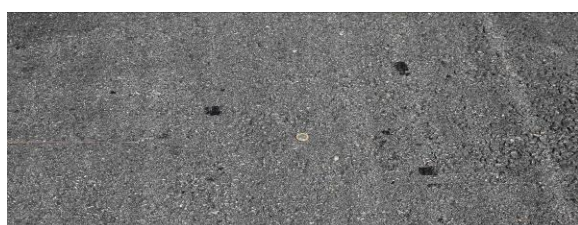
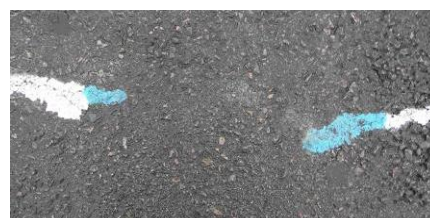
(a) At 300 000 load cycles

(b) At 450 000 load cycles

Figure 4: Evolution of cracking of the pavement structure at position “P”

The first cracks were detected on the surface of the pavement after 350 000 load cycles. They appeared, as expected, at the ends of the steel bars placed in the pavement to initiate early cracks (Figure 4-b). At the same time, between 300 000 and 350 000 load cycles, the strain profile curves measured by the optical fibers started to change, the peak becoming wider and more flat in comparison with the previous measurements..

After 500 000 load cycles, the cracks still continued to grow, and new cracks appeared in the same area. At the end of the experimentation (728 000 load cycles), the pavement was severely damaged. As shown in figure Figure 4-d, at the end, the cracks were interconnected, creating a pattern called “alligator cracking”. It is worth to note that the fiber optic cable continued to respond well despite the severe cracking of the pavement structure. However, the multiple cracks cannot be clearly distinguished, because the distance between them is less than the length of the stress transfer mechanism.
