## Identification of inhomogeneous concrete cover by non-contact ultrasonic method

Bogdan Piwakowski, Qiang Liu, Jean-Paul Balayssac, Géraldine Villain, Vincent Garnier, et al.. Identification of inhomogeneous concrete cover by non-contact ultrasonic method. EWSHM - 7th European Workshop on Structural Health Monitoring, IFFSTTAR, Inria, Université de Nantes, Jul 2014, Nantes, France. hal-01022073

## IDENTIFICATION OF INHOMOGENEOUS CONCRETE COVER BY NON-CONTACT ULTRASONIC METHOD

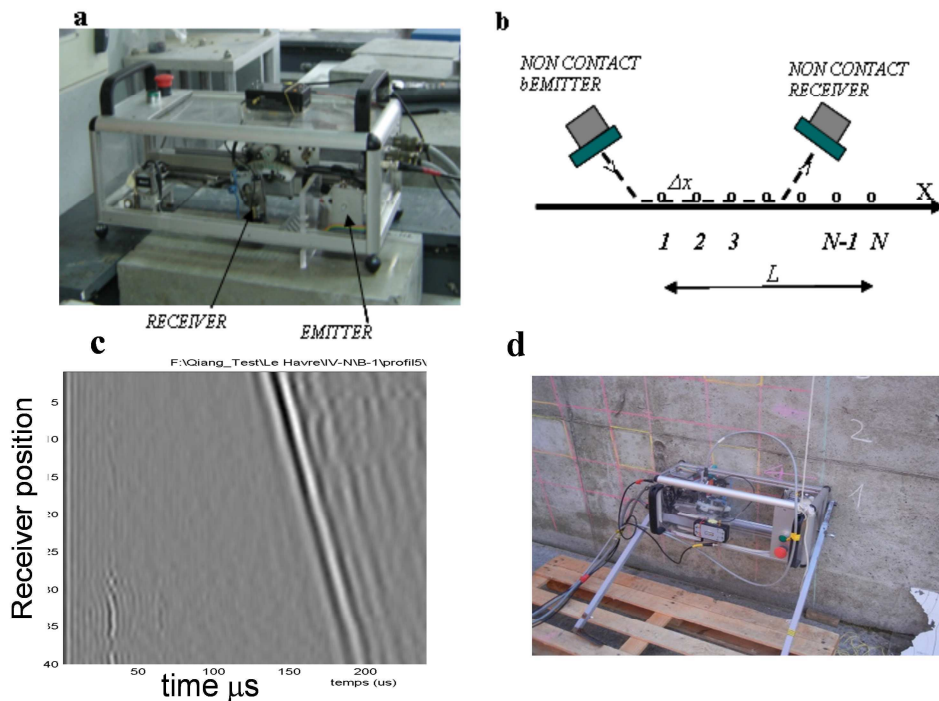
Figure.1.

(a) Automated non-contact scanner designed for the surface wave recording; (b) Acquisition geometry: the surface wave is recorded along a profile of length  $L$ , by means of moving receiver at  $N$  positions spaced of  $\Delta x$ ; (c) B scan of recorded surface wave, (d) Scanner in operation in outdoor conditions.

In this paper the methodology applied by the classical technique used for ground structure recovery, called Multichannel Analysis of Surface Waves (MASW), [4], is considered as the NDT tool to characterize the concrete cover. The emission, reception and acquisition of SW is carrier out by the non-contact ultrasonic scanner, [2], illustrated in Fig. 1.a. The SW is generated by a non-contact emitter the position of which is fixed. In order to assure the SW generation, the inclination angle of the emitter is to be set close the second critical angle of transmission via air/concrete interface. The reception of SW along a straight line profile of length  $L$ , at  $N$  points, spaced by  $\Delta x$ , takes place by the non-contact wideband (20-900 kHz) receiver, also inclined at critical angle. The receiver moves along the measured profile (Fig.1.b). The applied solution assures fully non-contact test which permits to avoid a modification of concrete surface by a coupling agent and a time consuming coupling procedure. Moreover, it enables quick, precise automatic measurements and scanner displacements. The B scan of SW pulses recorded for a single profile is illustrated in Fig. 1.c. The scanner can be used in laboratory and in outdoor conditions at any planar surface (wall, floor, ceiling), Fig. 1d. The recorded SW signals are used to determine dispersion characteristics  $V(f)$  which is then explored in order to gain information concerning inhomogeneity of studied materials, i.e. the thickness of the cover layer and material parameters as functions of the inspected position.

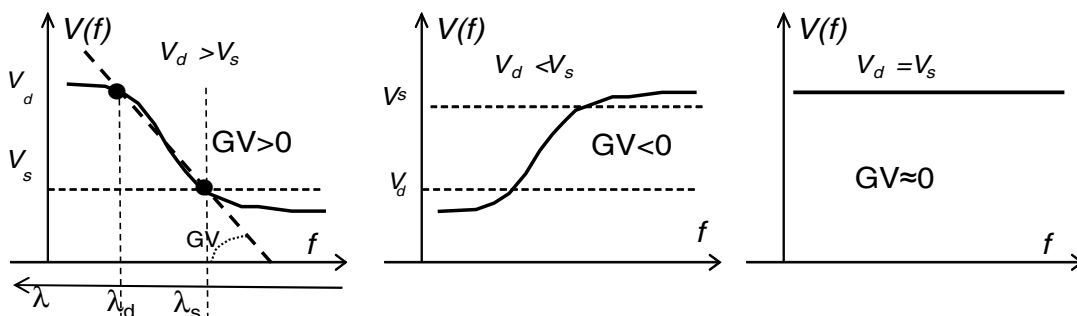
Figure 2. Three basic shapes of dispersion characteristics V(f) and corresponding GV values

- Case 1: Porosity P (including micro-cracks) is greater at the surface and W does not change much; consequently V<sub>s</sub> is smaller than velocity of deep sound concrete: V<sub>s</sub> < V<sub>d</sub>.
- Case 2: Water content W is greater at the surface than in deeper concrete and P remains constant; this results in V<sub>s</sub> > V<sub>d</sub>.
- Case 3: Concrete is quasi homogenous and this means that V is quasi constant: V ≈ V<sub>s</sub> ≈ V<sub>d</sub> ≈ constant.

The above three cases result in specific shape of dispersion characteristics V(f), as illustrated in Fig. 1.

In order to quantify in a simple way the presence of the surface inhomogeneity the Velocity Gradient (GV) parameter is introduced. It is defined as a mean slope of dispersion V(λ=V/f) for interval λ<sub>s</sub> < λ < λ<sub>d</sub>

Thus the parameter GV expresses approximately the velocity variation from the depth λ<sub>s</sub> to λ<sub>d</sub>. The wavelength limits λ<sub>s</sub> = V(f<sub>max</sub>)/f<sub>max</sub> and λ<sub>d</sub> = V(f<sub>min</sub>)/f<sub>min</sub> correspond to frequency band [f<sub>min</sub>, f<sub>max</sub>], which is to be appropriately selected in order to assure that GV is determined with signal to noise ratio sufficiently high. The band [f<sub>min</sub>, f<sub>max</sub>] depends in particular on the frequency bandwidth of the applied emitter. In practice, because of aggregate size and intrinsic attenuation f<sub>max</sub>

does not exceed 250 kHz. For concrete with homogeneous moisture content, when  $GV > 0$  it indicates that the concrete is more degraded at its surface (the case just illustrated in Fig.1.c). In the opposite case, if  $GV < 0$  this might indicate that the surface layer is stiffer than the deeper part due to for example carbonization effect.

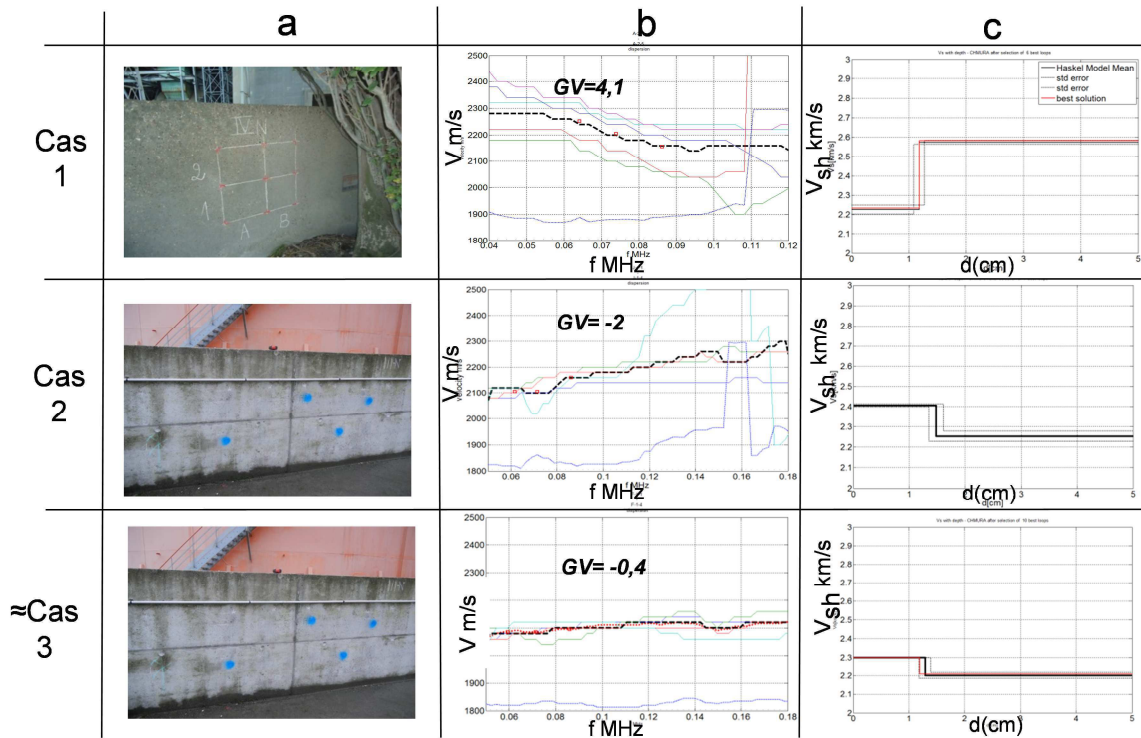
Figure 3. Procedure of concrete cover inspection using gradient velocity parameter: (a) Inspected concrete walls, (b) Dispersions characteristics  $V(f)$  illustrating three different cases of  $V(f)$  shape (c), Inversion results showing the transversal velocity  $V_s$  as the function of depth  $d$ .

The procedure of characterization of concrete cover using the introduced above gradient analysis is illustrated in Figure 3. The three presented results were obtained during on site measurements (for details see next section). The column (b) of the Figure 1 shows the dispersion characteristics  $V(f)$  chosen in order to illustrate three cases defined previously. The column (c) provides the results of inversion, i.e shear wave velocity  $V_{sh}$  versus depth  $d$ . The inversion is performed using CLOUD software, developed for laboratory studies, tested and validated on the model multilayered samples, [3,6]. The inversion procedure assumes the presence of two layers. The obtained results indicate that the structure of the concrete cover fits to the two layered model. In order to validate the above results, the depth of carbonization are compared with those obtained from the cores extracted from inspected walls and characterized using special protocol [7] developed within the frame of C2D2-ACDC project [8].

- Case 1:  $GV > 0$ , corresponds to 65 years old (old) concrete displaying the clear signs of damage. The depth of carbonization found from the core samples is there about 29 mm and the inversion gives cover thickness  $d = 11.8$  mm. This suggests that the surface damage (micro cracks, porosity) dominates the effect of surface humidity and perhaps of carbonization (this latter may cause different effects)

- Case 2:  $GV < 0$ , corresponds to 10 years old (young) concrete of good quality. The negative value of  $GV$  suggests that carbonization and humidity may dominate. The depth of carbonization found from the core tests gives 3 - 4 mm, meanwhile the inversion technique indicates  $d = 14$  mm. This difference can be explained by e.g. deeper penetration of moisture than carbonization. This example indicates that finding the carbonization depth by using the inversion method (often the objective of interest) may be à priori not possible, except the instances when the influence of the phenomena on  $V(f)$  could be separated.

- Case 3:  $GV \approx 0$ , is chosen in order to show the situation where  $V(f)$  is nearly constant (although on site obtaining  $V(f)$  constant is rarely met). The result is obtained for the same wall that was studied in Case 2, but the position is different. This shows that local variations of  $GV$  can be relatively strong.

The quantitative information for the three cases illustrated in Figure 3 are summarized in Table 1.

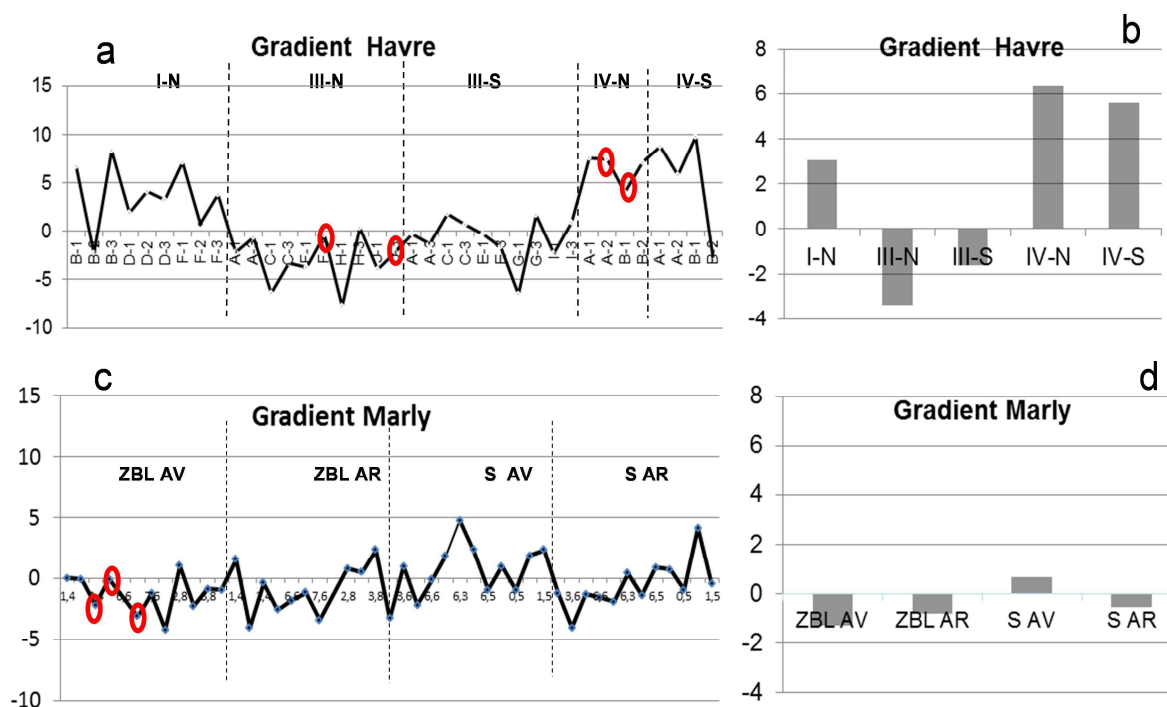
Figure4. (a) Site near Havre, gradients  $GV_{mesh}$  over all inspected walls; (b) Site near Havre, Gradients  $GV_{side}$  for all inspected walls;- (c) Site near Marly,  $GV_{mesh}$  over all inspected walls; (d) Site near Marly, Gradients  $GV_{side}$  for all inspected walls (the circles indicate the locations described in tables 1 and 2)

Figure 4.a shows  $GV_{mesh}$  obtained for all inspected walls. One can notice a great variability of  $GV$  within the same wall. In order to obtain more representative global characteristic, the mean gradient  $GV_{side}$  was determined for each site (Fig.b). The analysis of the results indicates that old walls display  $GV > 0$ , thus suggesting that the concrete cover is not so stiff as the deeper concrete which may be related to higher porosity and micro cracks in the cover (case 1 from Figure 3). On the other

hand the younger wall III displays  $GV < 0$ , thus indicating opposite behavior, possibly higher influence of water content and limited effect of porosity (case 2 from Figure 3).

The values of gradients (GV) for the sites are shown in cells (c) and (d) of Figure 4. It is clearly visible that the gradients are considerably smaller than the gradients obtained for the site near Havre. Notice that certain areas display even gradient close to zero ( $GV_{maille} \approx 0$ ), corresponding to case 3 from Figures 2 and 3. The mean gradients  $GV_{face}$  are also relatively very small, thus indicating that all piles are rather in good state. For three sites,  $GV_{face}$  are slightly negative just indicating the influence of the moisture. Only one site for pile S, most exposed to environmental variations, displays  $GV_{face}$  slightly positive and this could be interpreted as the first stage of the porosity changes caused by damage.

Table 2 gives the results of identification of parameters by inversion method, particularly the carbonization depth (measured from core tests) for the three areas denoted by circles in Fig.4.c,
