Assessment of cracks detection in pavement by a distributed fiber optic sensing technology

Xavier Chapeleau, Juliette Blanc, Pierre Horny, Jean-Luc Gautier, Jean Carroget

Xavier Chapeleau, Juliette Blanc, Pierre Horny, Jean-Luc Gautier, Jean Carroget. Assessment of cracks detection in pavement by a distributed fiber optic sensing technology. *Journal of Civil Structural Health Monitoring*, 2017, 7 (4), pp.459-470. 10.1007/s13349-017-0236-5 . hal-01582525

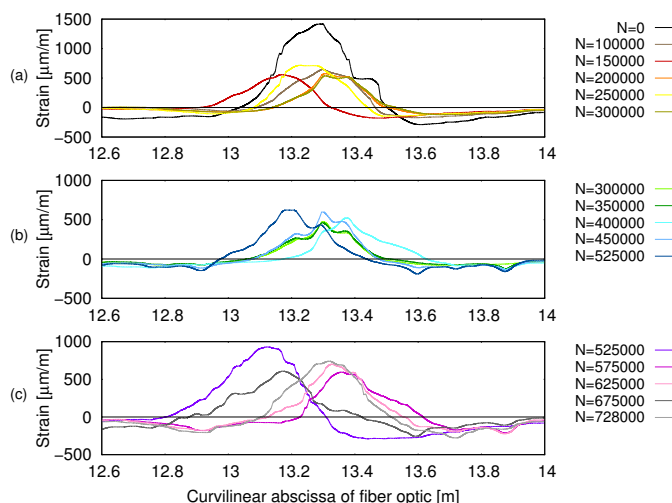
Fig. 8 Strains profiles obtained with loading at position "S" (structure HMAM).

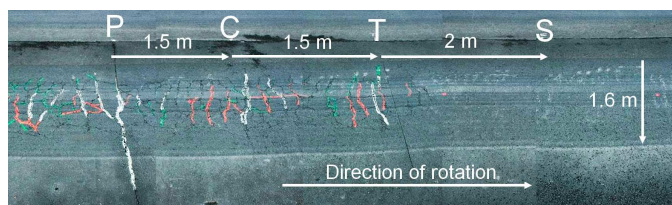
Fig. 9 Photograph of cracked pavement section HMAM at the end of the experimentation.

At the end of the experimentation, a large part of the pavement HMAM structure between positions "P" and "T" was severely damaged (Figure 9). The cracks were interconnected, creating a pattern called "alligator cracking". It is worth to note that the fiber optic cable continued to respond well despite the severe cracking of the pavement structure. However, the multiple cracks could not be clearly distinguished, because the distance between them is less than the length of the stress transfer mechanism.
