## Assessment of cracks detection in pavement by a distributed fiber optic sensing technology

Xavier Chapeleau, Juliette Blanc, Pierre Hornyh, Jean-Luc Gautier, Jean Carroget

Xavier Chapeleau, Juliette Blanc, Pierre Hornyh, Jean-Luc Gautier, Jean Carroget. Assessment of cracks detection in pavement by a distributed fiber optic sensing technology. *Journal of Civil Structural Health Monitoring*, 2017, 7 (4), pp.459-470. 10.1007/s13349-017-0236-5 . hal-01582525

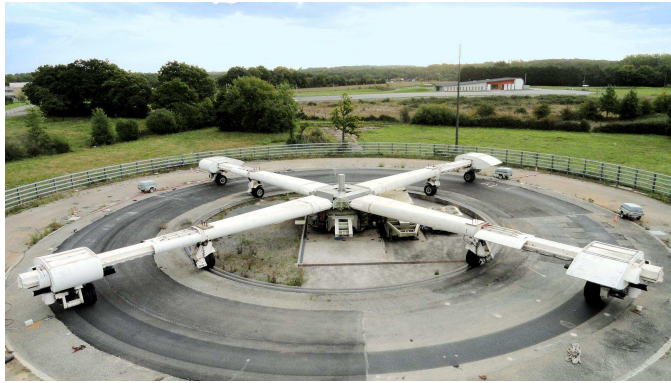
**Fig. 1** Accelerated pavement testing facility of IFSTTAR.

42  
43 The IFSTTAR accelerated pavement testing facility (Figure 1), in Nantes  
44 (France), is an outdoor circular carousel dedicated to full-scale pavement ex-  
45 periments, carried out with public and/or private partners. The carousel con-  
46 sists of a central tower and four arms (each 20 m long) equipped with wheels,  
47 running on a circular test track. The experimental circular pavement has a  
48 mean radius of 17.5 m and a width of 6 m, and thus a total length of ap-  
49 proximately 110 m. The position of the loading modules can be adjusted for  
50  
51  
52  
53  
54  
55  
56  
57  
58  
59  
60  
61  
62  
63  
64  
65

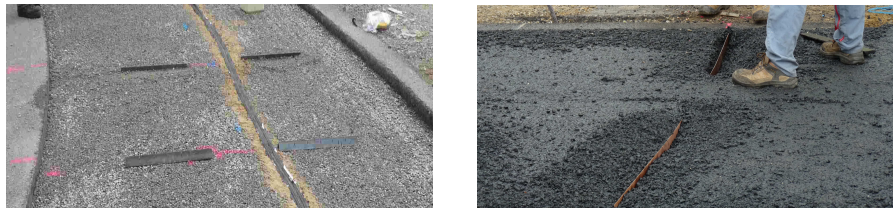
**Fig. 2** Photographs showing the different types of steel bars embedded in the asphalt.

To accelerate damage (crack initiation in the pavement), steel bars with different shapes (triangular, T shaped and flat) were placed in the layer of asphalt as shown on Figures 2. The triangular steel bars (4 cm high) and the T shaped steel bars (4 cm high) were placed on top of the unbound granular material. The flat steel bars were put in the asphalt layer after the overlay and before the compaction. The asphalt was taken away with a trowel and the flat steel bars were pushed in with a hammer. All the steel bars were placed transversely to the wheel path axis as shown on figures 3 and 4. The distance between two identical shape steel bars is approximately 40 cm. It was expected that a crack would initiate at an early stage and propagate transversely to the wheel path axis between the two steel bars of the same shape.

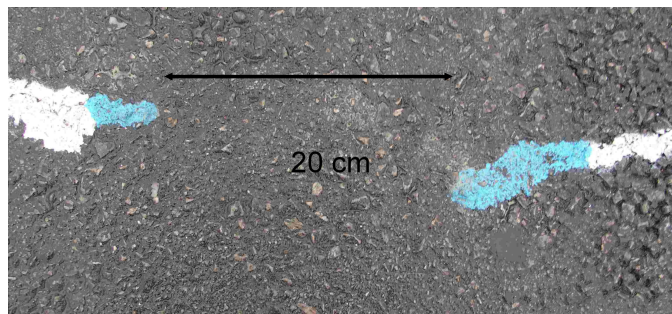
**Fig. 6** Evolution of the first crack in the HMAM pavement structure localized at position "P" at 426 000 load cycles.

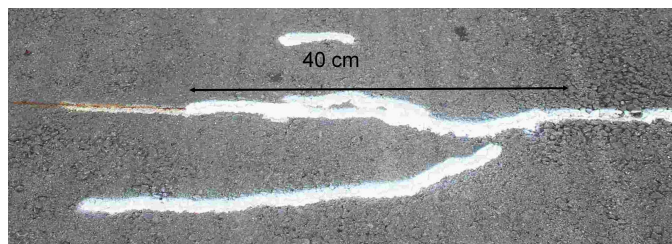
**Fig. 7** Evolution of the first crack in the HMAM pavement structure localized at position "P" at 525 000 load cycles.

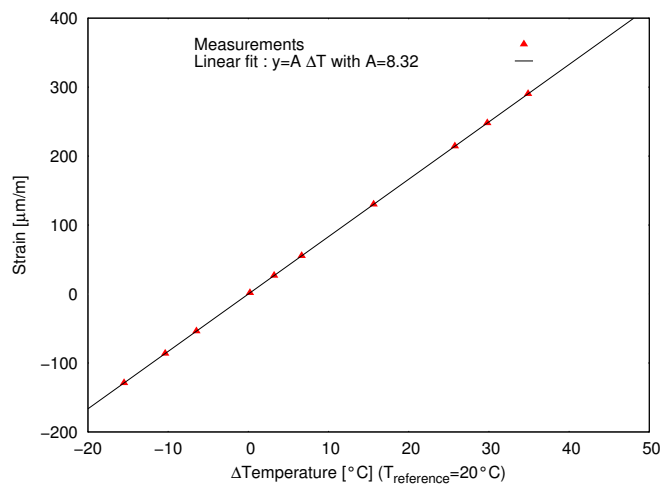
**Fig. 14** Calibration of the fiber optic cable embedded in HMAM layer.

of the refractive index of the fiber optic with temperature, which shifts the Rayleigh backscattered pattern. This thermo-optic effect is generally the most important. The results on Figure 14 indicate a linear variation of strain with temperature. The mean slope of this curve is  $8.32 \mu\text{m}/\text{m}/^\circ\text{C}$ , and represents a correction factor which can be used to correct the measured strains.

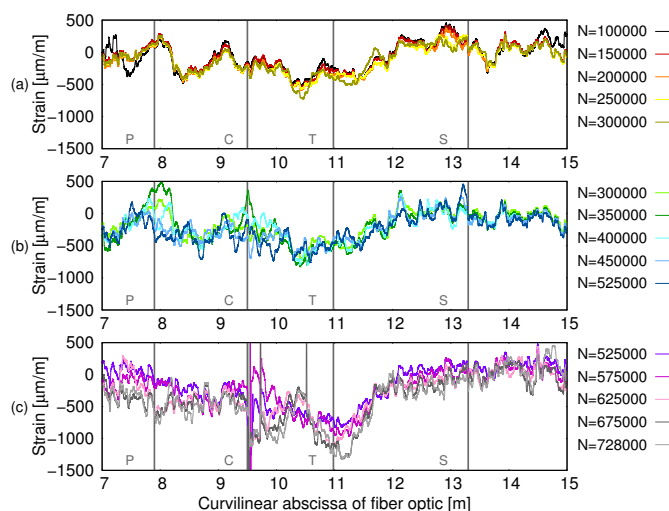
**Fig. 15** Strains profiles obtained without loading (structure HMAM).

Figures 15 and 16 present the strain profile curves obtained with method B for the HMAM and DGBM structures, respectively. They are compensated in temperature by using the calibration described above. At 100000 load cycles, the 2 figures show somewhat irregular strain profiles. These irregular variations are probably due to post-compaction of the asphalt layer caused by the applied wheel loads, at the beginning of the experiment. After this phase, no significant evolution of the strain profiles occurs between 100000 and 300000 load cycles, and a very good repeatability of the measurements can be observed. As described before, no cracks were detected on the 2 pavement structures by visual inspection and by fiber optic measurements (using method A) during this period.

For the HMAM structure, at 350000 load cycles, first significant changes can be observed on the strain profiles. The positions where these changes occur ( $x=8 \text{ m}$  and  $x=9.5 \text{ m}$ ) correspond well to the positions of the first cracks on the pavement, which were detected several thousand cycles later. At 400000 load cycles, two strain peaks appear at position "P" ( $x=8 \text{ m}$ ) corresponding to the two cracks observed close to this point (Figure 7). At 525000 load cycles, the entire strain profile located between  $x=7 \text{ m}$  and  $x=12 \text{ m}$  is strongly modified. This corresponds to the appearance and growth of various cracks in this area (Figure 9). For the portion of the fiber optic located between  $x=12 \text{ m}$  and  $x=15 \text{ m}$ , however, the change of the strain profile curves is less significant.

This is in accordance with the fact that no cracks were detected by visual inspection for  $x > 12$  m, until the end of the experimentation.

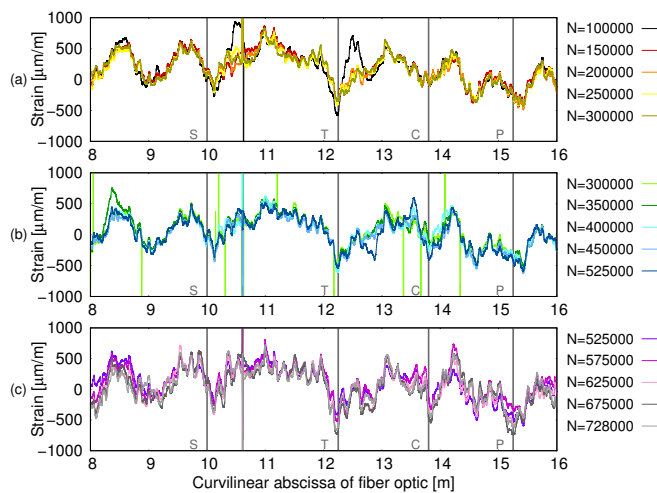
**Fig. 16** Strains profiles obtained with loading (structure DGBM).

For the DGBM structure (Figure 16), the results are different. The strain profiles remain very similar to that measured at 100 000 load cycles up to the end of the experiment. These results are consistent with the observations made on this section, which indicated that cracking was less severe, and that the cracks were mostly superficial. This result is interesting, because it indicates that in the absence of significant cracks, which intercept the fiber optic cable, the strain profile measured by the fiber optic cable remains relatively stable.
