## Assessment of cracks detection in pavement by a distributed fiber optic sensing technology

Xavier Chapeleau, Juliette Blanc, Pierre Hornyh, Jean-Luc Gautier, Jean Carroget

Xavier Chapeleau, Juliette Blanc, Pierre Hornyh, Jean-Luc Gautier, Jean Carroget. Assessment of cracks detection in pavement by a distributed fiber optic sensing technology. *Journal of Civil Structural Health Monitoring*, 2017, 7 (4), pp.459-470. 10.1007/s13349-017-0236-5 . hal-01582525

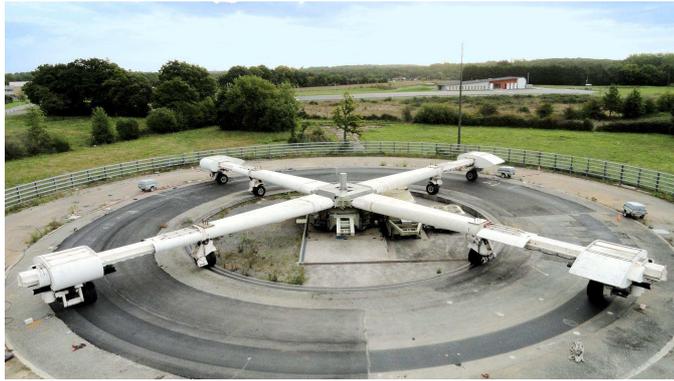
**Fig. 1** Accelerated pavement testing facility of IFSTTAR.

41  
42 The IFSTTAR accelerated pavement testing facility (Figure 1), in Nantes  
43 (France), is an outdoor circular carousel dedicated to full-scale pavement ex-  
44 periments, carried out with public and/or private partners. The carousel con-  
45 sists of a central tower and four arms (each 20 m long) equipped with wheels,  
46 running on a circular test track. The experimental circular pavement has a  
47 mean radius of 17.5 m and a width of 6 m, and thus a total length of ap-  
48 proximately 110 m. The position of the loading modules can be adjusted for  
49  
50  
51  
52  
53  
54  
55  
56  
57  
58  
59  
60  
61  
62  
63  
64  
65

different radii on each arm, for instance to test simultaneously the effect of different load configurations. During loading, a lateral wandering of the loads can be applied to simulate the lateral distribution of loads due to real traffic [18], [19]. The maximum operating speed is 100 km/h, which allows to apply approximately 1 million loads per month.

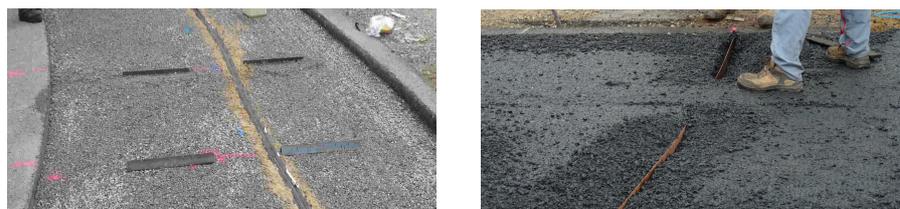
**Fig. 2** Photographs showing the different types of steel bars embedded in the asphalt.

To accelerate damage (crack initiation in the pavement), steel bars with different shapes (triangular, T shaped and flat) were placed in the layer of asphalt as shown on Figures 2. The triangular steel bars (4 cm high) and the T shaped steel bars (4 cm high) were placed on top of the unbound granular material. The flat steel bars were put in the asphalt layer after the overlay and before the compaction. The asphalt was taken away with a trowel and the flat steel bars were pushed in with a hammer. All the steel bars were placed transversely to the wheel path axis as shown on figures 3 and 4. The distance between two identical shape steel bars is approximately 40 cm. It was expected that a crack would initiate at an early stage and propagate transversely to the wheel path axis between the two steel bars of the same shape.

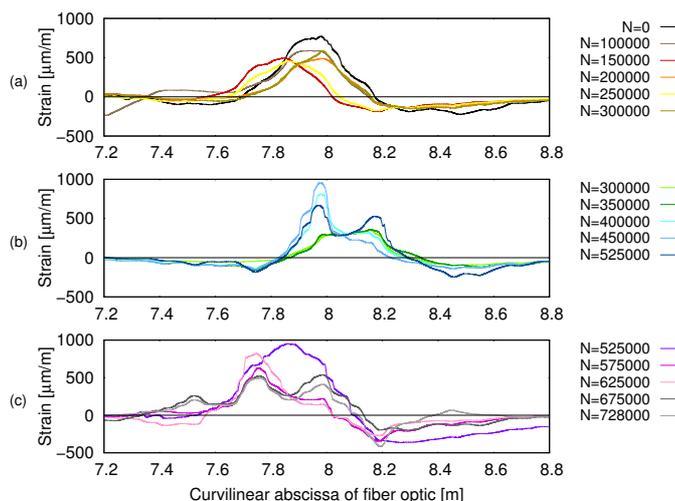
**Fig. 5** Strains profiles obtained with loading at position "P" (structure HMAM).

Figure 5 shows the strain profiles measured at different numbers of load cycles, with a static load applied at the position "P" (where the flat steel bars were placed to initiate cracking) for the structure HMAM (with high modulus asphalt mix). All the strain profiles from the beginning of the experimentation to 300 000 load cycles have the same shape, which seems to indicate that no damage and no cracking occurred during this period. Note that the peaks are slightly shifted in abscissa due to the fact that the tire (the load) was not placed exactly at the same position for the different measurements. Indeed, regular visual inspections did not permit to detect any cracks on the pavement until 350 000 load cycles. The first cracks were detected on the surface of the pavement after 350 000 load cycles. They appeared, as expected, at the ends of the steel bars placed in the pavement to initiate early cracks (Figures 3 and 4). At the same time, between 300 000 and 350 000 load cycles, the strain profile curves measured by the optical fibers started to change, the peak becoming wider and more flat in comparison with the previous measurements.

After 400 000 and 450 000 loads cycles, the maximum of the peak of the strain profile curves continued to increase and simultaneously, the surface crack propagated over the whole width of the pavement section. However, at the beginning, the crack remained very thin and difficult to detect by human eye. Then, at 525 000 load cycles, the crack observed on the surface split in two cracks (Figures 6 and 7), and at the same-time, a second peak appeared on the strain profile. This result shows clearly the ability of the optic fiber to detect

changed again, and at 728 000 load cycles, the two peaks were again clearly visible on Figure 5.

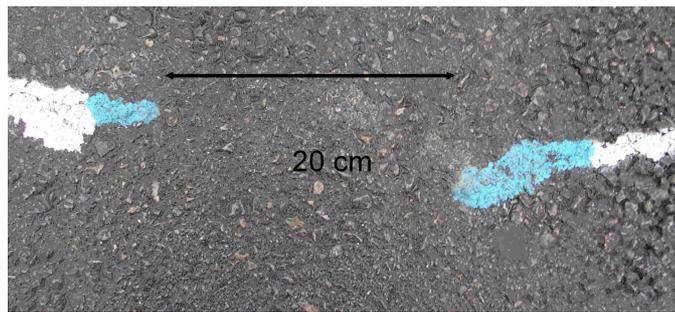
**Fig. 6** Evolution of the first crack in the HMAM pavement structure localized at position "P" at 426 000 load cycles.

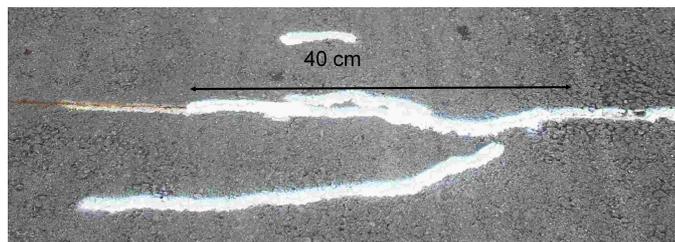
**Fig. 7** Evolution of the first crack in the HMAM pavement structure localized at position "P" at 525 000 load cycles.

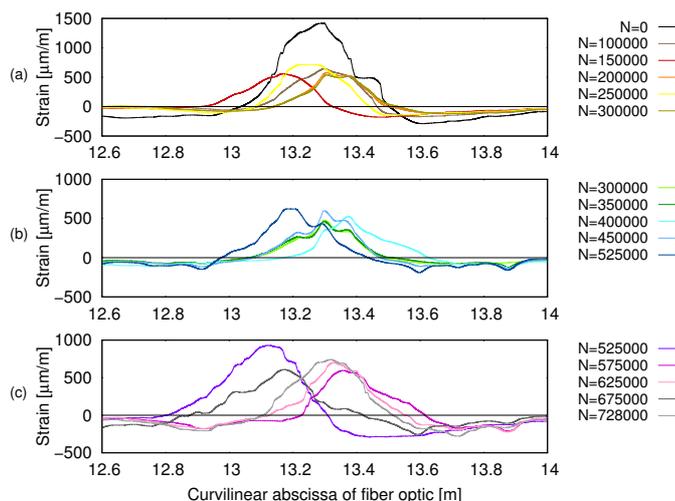
Fig. 8 Strains profiles obtained with loading at position "S" (structure HMAM).

After this first test phase, the fatigue carousel was stopped during 8 months due to testing schedule reasons and maintenance operations (between January 2012 and mid-August 2013). Then, a new measurement was made after this rest period at 525000 load cycles. As shown on Figure 5, the two peaks in the strain profile has disappeared. This can probably be explained by a self healing of the bituminous material during the stop of the fatigue carousel. It is a known but not well understood phenomenon which can occur during hot periods and long rest periods. After 50 000 new load cycles, the strain profile

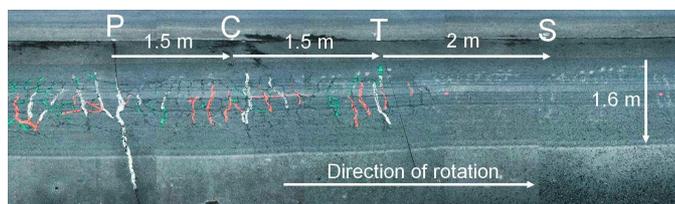
Fig. 9 Photograph of cracked pavement section HMAM at the end of the experimentation.

At the end of the experimentation, a large part of the pavement HMAM structure between positions "P" and "T" was severely damaged (Figure 9). The cracks were interconnected, creating a pattern called "alligator cracking". It is worth to note that the fiber optic cable continued to respond well despite the severe cracking of the pavement structure. However, the multiple cracks could not be clearly distinguished, because the distance between them is less than the length of the stress transfer mechanism.

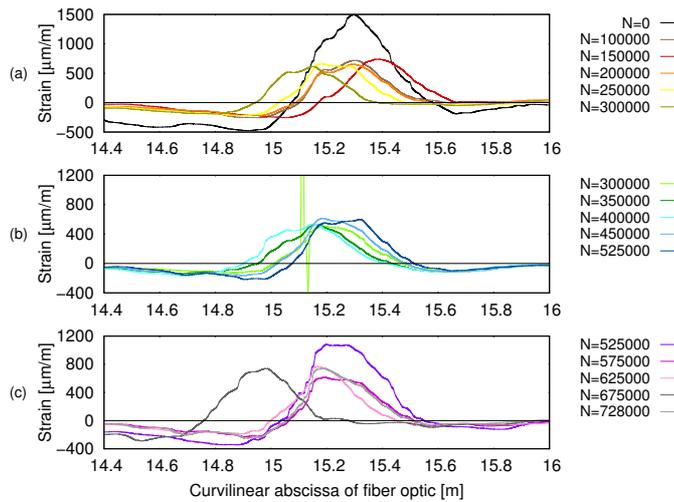
**Fig. 10** Strains profiles obtained with loading at position "P" (structure DGBM).

The second pavement structure consisted of an 8 cm thick layer of DGBM. This is a wearing course material, made with a softer bitumen grade (35/50) than the high modulus asphalt material, and having a lower stiffness. This structure also presented some damage at the end of the experimentation, but the cracking was less severe, and the cracks were much finer than on the HMAM section (see Figure 10). On this second structure, the measurements made with the fiber optic cables indicated no significant evolution of the strain

signals, all through the experiment. So, apparently, the fiber optic cables could not detect any significant cracking on that structure.

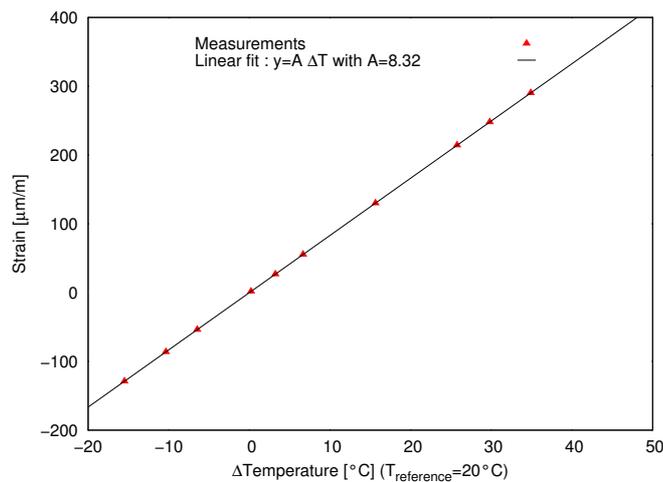
**Fig. 14** Calibration of the fiber optic cable embedded in HMAM layer.

be placed at different positions along the fiber optic cable, and because the lane must be closed to traffic during the measurements. Due to these limitations, a second monitoring method has also been tested. This method consists in making only one measurement, without any load, at different numbers  $N$  of load cycles, and in comparing this measurement at cycle  $N$  with a reference measurement, made at the start of the experiment, on the new pavement. This second method is more acceptable for road managers because it is faster and limits the disturbance of the traffic. However, with method B, the Rayleigh signal measurements were made at large time intervals (several weeks or months), and thus at different seasons, and very different temperatures. For this reason, a temperature compensation appeared necessary to correct temperature dependence of the fiber optic cable response. To calibrate it, a small plate (40 cm x 20 cm x 10 cm) of HMAM containing a fiber optic cable was fabricated. This specimen was then placed in a thermal chamber and Rayleigh signal measurements were performed at temperatures from 5 °C to 60 °C by steps of 5 °C. Note that the measurements were made at interval of 24 h to ensure thermal stabilization of the specimen. From these measurements, strain profiles were calculated, taking the measurement at 20 °C as reference. Figure 14 shows the strain variations with temperature. Note that the ordinate of the graph is not real strain. The strain variations result from two effects. The first effect is the thermal expansion or contraction of the fiber optic sensor and surrounding material. The second effect is the dependence

of the refractive index of the fiber optic with temperature, which shifts the Rayleigh backscattered pattern. This thermo-optic effect is generally the most important. The results on Figure 14 indicate a linear variation of strain with temperature. The mean slope of this curve is  $8.32 \mu\text{m}/\text{m}/^\circ\text{C}$ , and represents a correction factor which can be used to correct the measured strains.

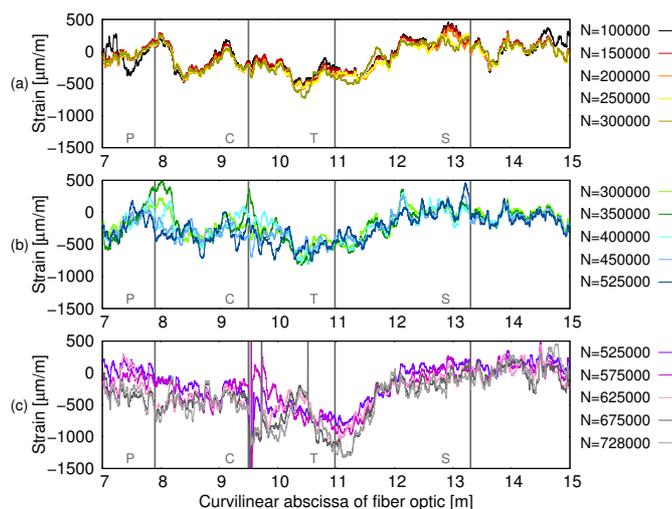
**Fig. 15** Strains profiles obtained without loading (structure HMAM).

Figures 15 and 16 present the strain profile curves obtained with method B for the HMAM and DGBM structures, respectively. They are compensated in temperature by using the calibration described above. At 100000 load cycles, the 2 figures show somewhat irregular strain profiles. These irregular variations are probably due to post-compaction of the asphalt layer caused by the applied wheel loads, at the beginning of the experiment. After this phase, no significant evolution of the strain profiles occurs between 100000 and 300000 load cycles, and a very good repeatability of the measurements can be observed. As described before, no cracks were detected on the 2 pavement structures by visual inspection and by fiber optic measurements (using method A) during this period.

For the HMAM structure, at 350000 load cycles, first significant changes can be observed on the strain profiles. The positions where these changes occur ( $x=8 \text{ m}$  and  $x=9.5 \text{ m}$ ) correspond well to the positions of the first cracks on the pavement, which were detected several thousand cycles later. At 400000 load cycles, two strain peaks appear at position "P" ( $x=8 \text{ m}$ ) corresponding to the two cracks observed close to this point (Figure 7). At 525000 load cycles, the entire strain profile located between  $x=7 \text{ m}$  and  $x=12 \text{ m}$  is strongly modified. This corresponds to the appearance and growth of various cracks in this area (Figure 9). For the portion of the fiber optic located between  $x=12 \text{ m}$  and  $x=15 \text{ m}$ , however, the change of the strain profile curves is less significant.

This is in accordance with the fact that no cracks were detected by visual inspection for  $x > 12$  m, until the end of the experimentation.

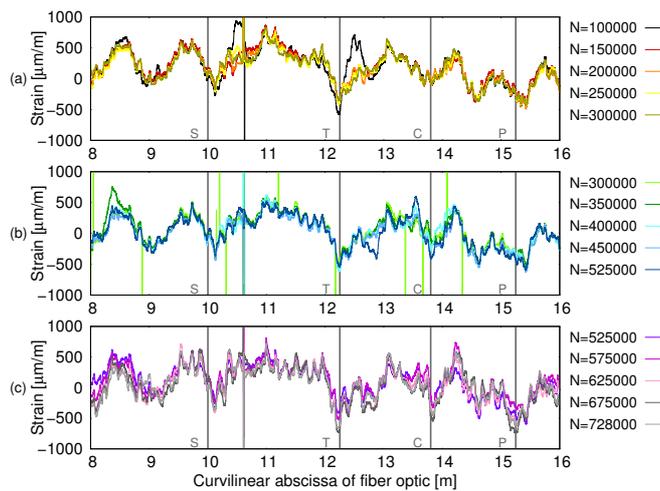
**Fig. 16** Strains profiles obtained with loading (structure DGBM).

For the DGBM structure (Figure 16), the results are different. The strain profiles remain very similar to that measured at 100 000 load cycles up to the end of the experiment. These results are consistent with the observations made on this section, which indicated that cracking was less severe, and that the cracks were mostly superficial. This result is interesting, because it indicates that in the absence of significant cracks, which intercept the fiber optic cable, the strain profile measured by the fiber optic cable remains relatively stable.
