# Detectability Assessment of Optical Fiber Sensor Based Impact Damage Detection for Composite Airframe Structures

## DETECTABILITY ASSESSMENT OF OPTICAL FIBER SENSOR BASED IMPACT DAMAGE DETECTION FOR COMPOSITE AIRFRAME STRUCTURE

**KEYWORDS :** *Optical fiber sensor, Fiber Bragg grating (FBG), Impact damage, Composite airframe structure*

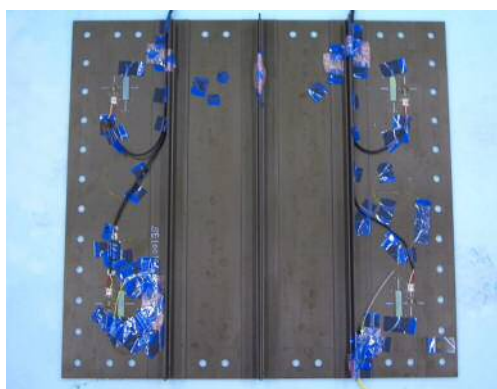
Figure 2: CFRP stiffened panel for simulated vibration test  
(Looking from stringer side)

The impact tests under vibration were performed to assess the impact detectability of IDDS under simulated vibration condition. In this test, a quasi-isotropic Carbon Fiber Reinforced Plastics (CFRP) stiffened panel shown in Figure 2 was used. The panel has three T-shape stringers. The size of the skin is 600x630x3mm. One optical fiber with 4 FBG sensors was bonded on the stringer side surface of the specimen. The sensor directions were aligned parallel with the stringers. The diameter of bonded optical fiber is 125 micro meter. The applied vibration condition was vertical random vibration of 5.83 Grms with the frequency range of 10Hz to 2000Hz. This condition is based on RTCA DO-160, Section 8, Category R, which is applicable to the fuselage of fixed wing turbojet airplane. The stiffened panel was set to the shaker by the test fixture as shown in Figure 3. Impacts were applied using an impact hammer under the random vibration. The impact load was approximately 1.5kN, which did not cause any impact damage.

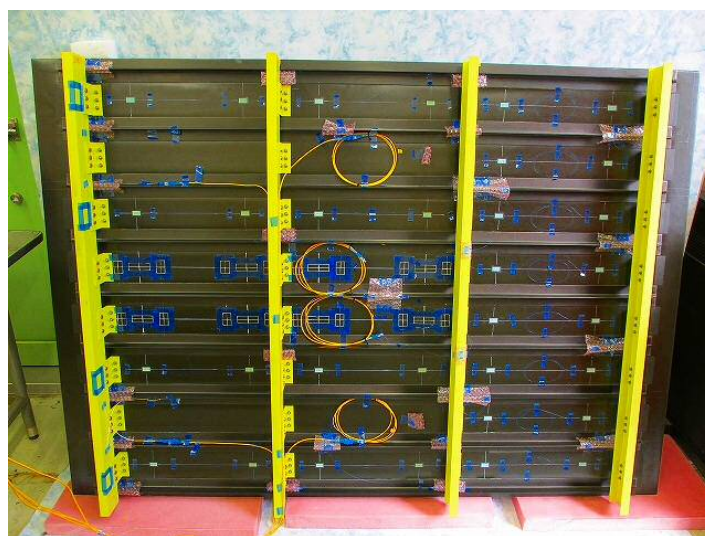
Figure 6: CFRP stiffened panel  
(Looking from stringer side)

In the study on the optimal FBG sensor direction, impact tests were performed for three types of FBG sensor alignment patterns using a CFRP stiffened panel imitating an actual aircraft structure as shown in Figure 6. This stiffened panel consists of quasi-isotropic CFRP skin, 9 CFRP T shaped stringers, 4 aluminium frames and 32 aluminium shear ties. The frames were fastened to the skin via shear ties. The size of the skin is 1800x1300x3mm. 12 FBG sensors were bonded on the stringer-side skin surface. The diameter of the bonded optical fibers are 125 micro meter. The arrangement of FBG sensors is similar to a rosette type strain gage, aligned in the stringer direction, frame direction (perpendicular to the stringer) and at 45-degree direction as shown in Figure 7. FBG sensor signals were obtained at 800kHz sampling rate using high speed FBG measurement system AR5011A developed by Anritsu corporation in Japan. Localization errors were compared between three types of FBG alignment patterns and suitable sensor direction for impact localization was evaluated. 16 impacts were applied to the web and stringer foot of the stiffened panel, as shown in
