## THREE EXPERIMENTAL APPLICATIONS OF HEALTH ALGORITHMS TO IMPROVE INFRASTRUCTURE INSPECTION

Elizabeth K. Ervin

This paper presents three applications of structural health evaluation from data collection to damage location. The first test setup was a standard railway track with an adjustable sleeper to allow for artificial defects. The second test setup was a student-built reinforced concrete bridge with various rubber bearings to represent joint softening. The third test location was a skewed on-campus highway bridge built in 1940 with no maintenance record. The obtained data sets were analyzed with an in-house structural health evaluation program, performing modal decomposition and applying twelve different damage detection algorithms.

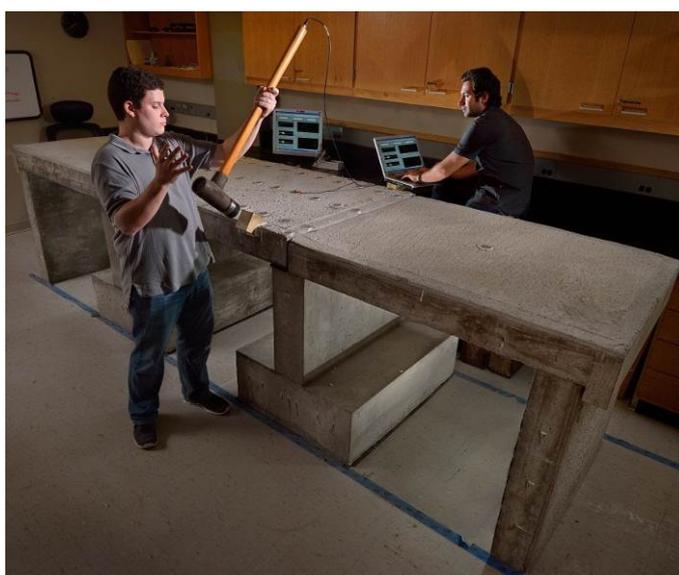
Figure 3: Graduate students performing impact hammer testing on the scale model bridge

Based upon the general dimensions of an on-campus bridge, a 1:12 scale model reinforced concrete bridge was built by students for expanded testing. The scaled bridge consisted of two inverted T-shaped piers, two end slabs with shear keys, two end walls, and one center slab. Note that the slab thicknesses were not to scale: since a two-inch slab is impractical, a six-inch minimum slab thickness was used for enough rebar cover. The scale model bridge pieces were precast in a single concrete pour. After 35 days, the pieces were unformed and assembled inside of the lab using a forklift. One surprise was that the three cubic yards of concrete tested at an unusually high average strength of 7,110 psi (ASTM C 172 and 143). The completed product is shown in Figure 3.

Weighing approximately 1270 pounds, the 60"x42"x6" center slab was the target of the vibration testing. A twelve-pound PCB sledge hammer (Figure 3) impacted a wood block on the bridge, inducing multi-dimensional vibrations. A Dytran tri-axial accelerometer on a level epoxy pad measured nearly imperceptible motions, and this was repeated for 57 spatially diverse locations for each damage case. Note that two measurements were on each approach slab, which proved very helpful in separating dissimilar modes. The other 55 measurements provided a grid that will allow for mode visualization in all three directions. A National Instruments CompactDAQ recorded the accelerometer signals via NI LabVIEW, and the csv time histories were loaded into the MATLAB structural health algorithm for post-processing.
