## EFFECT OF A DAMAGE TO MODAL PARAMETERS OF A WIND TURBINE BLADE

Gunner Chr. Larsen<sup>1</sup>, Peter Berring<sup>1</sup>, Dmitri Tcherniak<sup>2</sup>, Per Hørlyk Nielsen<sup>1</sup>, Kim Branner<sup>1</sup>

<sup>1</sup> DTU Wind Energy, Technical University of Denmark, P.O. Box 49, Roskilde 4000, Denmark

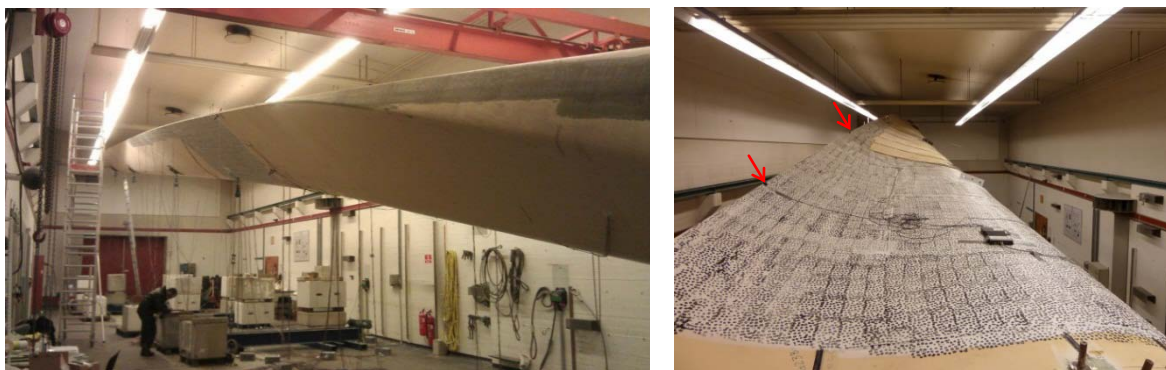
Figure 1: The 34m blade in the experimental Blade Test Facility at DTU Wind Energy. Left: Suction of blade. Right: Upper (pressure) side of blade. Accelerometers is marked with a red arrow

To study and compare the dynamic characteristics of a damaged wind turbine blade and the corresponding undamaged blade, a full-scale 34m blade, manufactured by SSP Technology A/S, was mounted to a test rig under laboratory conditions (cf. Figure 1). The blade was positioned horizontally with the suction side pointing towards the ground.

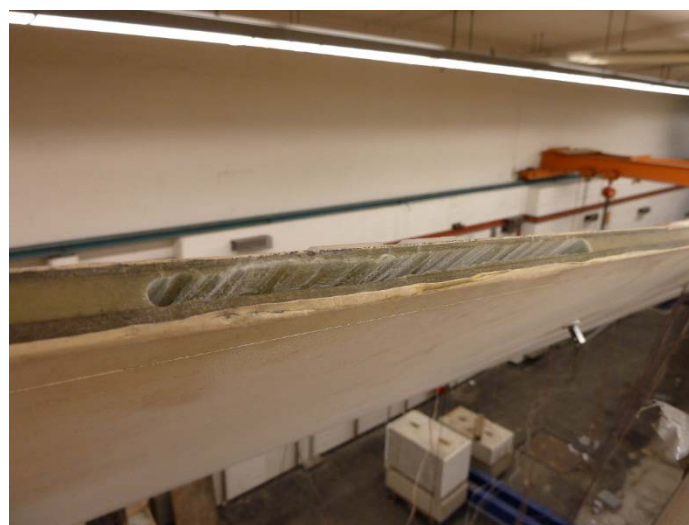
Figure 2: The artificial trailing edge damage introduced in the 34m blade

Several test campaigns were carried out throughout the experiment. The first test was carried out on the undamaged blade. This (reference) test was subsequently followed by tests, where artificial damages were introduced in the trailing edge 18,8m and onwards from the root. In the damaged part of the blade the adhesive between the upper and lower part of the shell was removed to mimic a crack in the trailing edge (cf. Figure 2). The first the damage had a length of 20cm along the blade, and this damage was progressively extended throughout the test campaigns, reaching a length of 120cm in the final test, and thus extending from 18,8m to 20,0m as measured from the blade root. The damaged part of the trailing edge was re-established after tests to enable the blade to be used for other experiments, and the first (reference) tests on the undamaged blade was repeated to investigate whether the re-established trailing edge had affected the dynamic properties of the blade.
