Damage Detection on a Cable Stayed Bridge Using Wave Propagation Analysis

Juan Quintana, Francisco Carrión, Saúl Crespo

Juan Quintana, Francisco Carrión, Saúl Crespo. Damage Detection on a Cable Stayed Bridge Using Wave Propagation Analysis. EWSHM - 7th European Workshop on Structural Health Monitoring, IFFSTTAR, Inria, Université de Nantes, Jul 2014, Nantes, France. hal-01022065

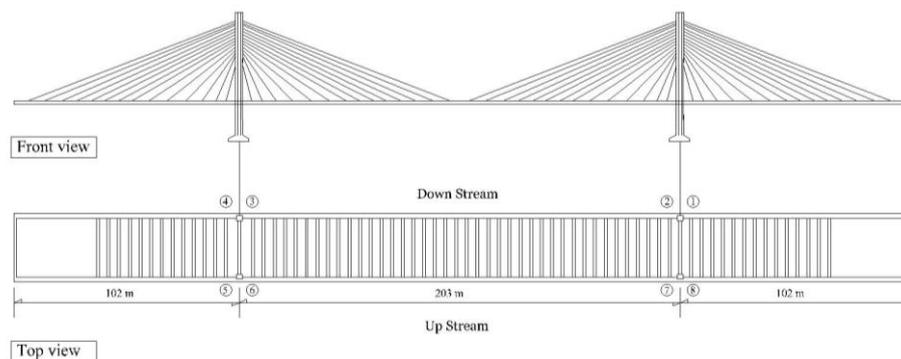
The Rio Papaloapan Bridge is located in the La Tinaja-Acayucan highway, in the state of Veracruz, Mexico. It was commissioned in 1995, and it is a stayed bridge with a span of 203 meters and an overall length of 407 meters. The bridge has 112 cables in 8 semi-harps with 14 cables each; semi-harps are numbered from 1 to 8 (figure 1), and cables are also identified from 1 to 14, starting with the shortest [1]. After 5 years of service, the upper anchorage element of cable 11, semi-harp 7, failed in 2000. In this case, a full fracture took place under normal operational conditions near the weld joint of the anchorage and the A-50 structural steel plate (embedded in the concrete tower).

Figure 1: Rio Papaloapan Bridge layout.

Figure 4a shows variations on the dynamic responses for sensor 11; the Y axis represents the difference between the experimental and simulated responses, while the X axis is the position of the cable with respect to the bridge deck from left to right (figure 1) so that, for example, cable 1 of semi-harp 6 is number 15. Here 3 curves are observed: the first (squares) represents the upstream cables; the second (diamonds), denotes the downstream cables; and the third (line) symbolizes the actual position of the removed cable.

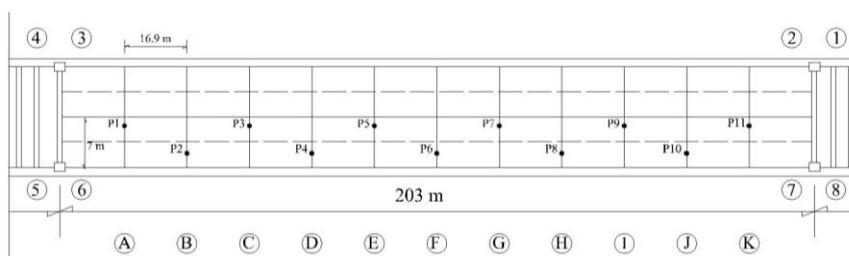
The second test consisted on dynamic tests where a controlled impact forces was applied at different points on the bridge deck. In this second case, 11 accelerometers on the deck were located on one side of the bridge between the two towers as indicated in figure 2. The impact forces were applied without traffic with a Dynatest falling weight deflectometer at different points on the deck. For this set of dynamic tests, a 2000 Hz sampling rate during 2 seconds was used for all sensors simultaneously; the experimental procedure was as follows:

Figure 2: Experimental arrangement for dynamic testing.

A set of dynamic tests was done at 10 different impact points on the deck before freeing the cable, and a similar set of 10 impacts was also done after release. At each point, the test was done 3 times for statistical analysis. The previous set of tests was used for calibration, while the second was used to evaluate the GSM.

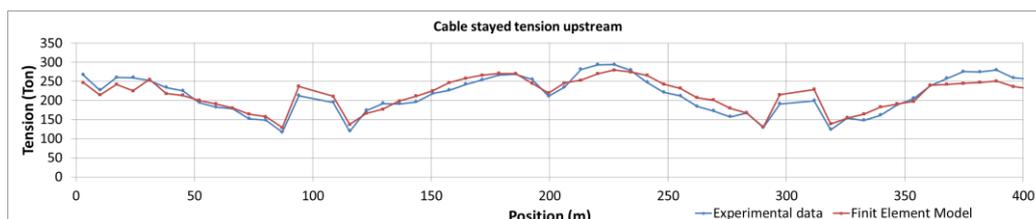
The unknown structural parameters were calculated using the dynamic responses or the initial condition, the pre-calibrated model and the software StrIdent [7,10], which is a StaDyn complementary software that solves inverse problems [11]. The model was considered as calibrated when tensions were within 10% from the experimental values with dead loads only. Figure 3 shows the comparison of the experimental tensions to those from the calibrated model.

Figure 3: Experimental and FEM Tensions.

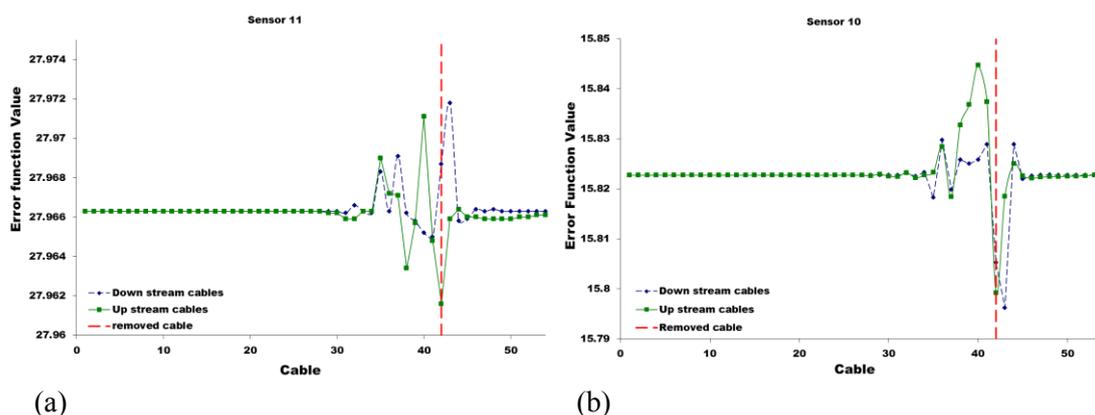
Dynamic response of sensor 11 is minimized at position 42 of the upstream cable figure 4a, which corresponds to the actual damage scenario. Figure 4b shows the same for sensor 10, where the minimum does not correspond to the real damage position and indicates the cable 1 of semi-harp 1 (position 43 of downstream cable), and the second minimum effectively corresponds to the actual damage position. It is important to note that, although the sensor 10 is not precise, it locates damage close to the actual position. When comparing sensor 10 with 11, clearly sensor 11 has higher sensitivity as it is closer to the damage location (4 meters of sensor 11 to 17 meters of sensor 10).

Figure 4: Objective function Values generated by the GSM. (a) Using sensor 11 data. (b) Using sensor 10 data.

In the case of sensor 9, it is different to sensors 10 and 11, since it is not able to locate the damage and even shows no error where it should be; minimums are indicated close or next, but not at the actual damaged position. Results from sensor 8 indicate damage adequately by the error function as it was for sensor 11, and somehow for sensor 10. At last, if the optimization of the error

function includes simultaneously the 4 sensor (8, 9, 10 and 11); again, the minimum location agrees with the position of the removed cable.

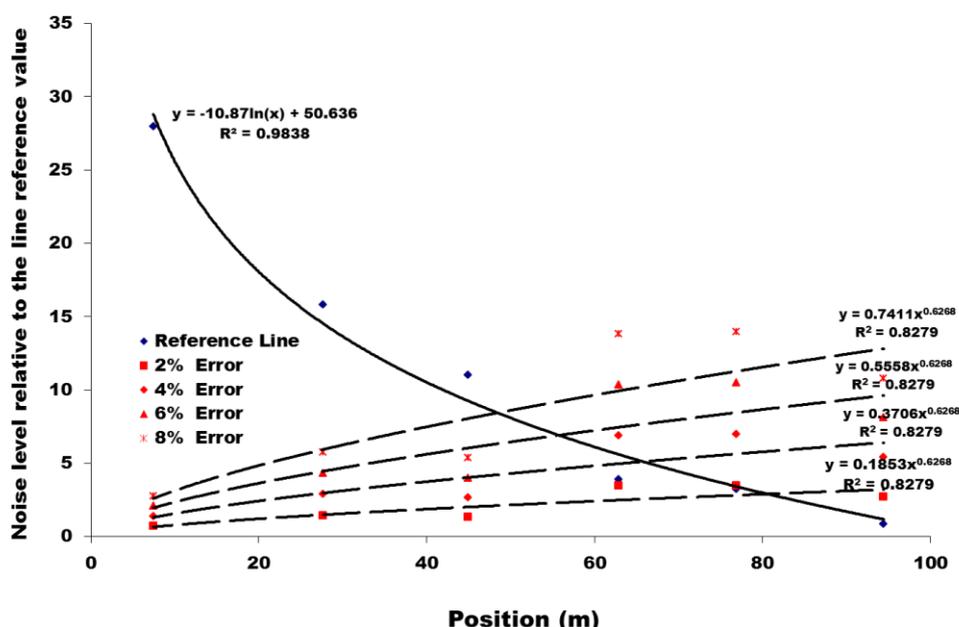
To analyze the GSM sensitivity with respect to the sensors position, the model calibration and the electronic noise, an overall noise was calculated with respect to the actual responses magnitude and normalized to the highest value of the reference line from the optimization process of the error function; which is the average of the optimized error of all positions. Then, the reference value is plotted to the distance and compared to different 2%, 4%, 6% and 8% noise levels, which are typical values obtained experimentally (figure 5). Clearly, from figure 5 it can be noticed that sensors 45 meters farther (like sensor 9), have little sensitivity with respect to noise and are not well suited for damage analysis of the particular simulated damage of cable 1. At the same time, if noise is reduced, including a better calibration and model response, the sensitivity increases in terms of amplitude and distance.

Figure 5: GSM sensitivity with respect to the sensors position.

The Global Search Method proved to be a useful tool for damage evaluation; its sensitivity depends on three main aspects: the FE model calibration, the sensor position with respect to damage and impact position, and the noise level in the experimental tests. For the Rio Papaloapan Bridge, this distance should be no more than 65 meters due to dispersion of the dynamic responses, the present noise and the sensors sensitivity. All these factors decrease the GSM sensitivity to the point that is not possible to measure differences between a damaged and undamaged condition, regardless it is a significant change like the rupture of a cable.
