Analysis on Snow Distribution on Sunlight Greenhouse and Its Distribution Coefficient

Chunhui Dai^{1,a}, Xiugen Jiang^{1,b}, *Min Ding^{1,c}, Dongxin Lv^{1,d}, Guilin Jia^{1,e}, Peng Zhang^{2,f}

¹College of Water Resources & Civil Engineering, China Agricultural University, Beijing 100083, China;

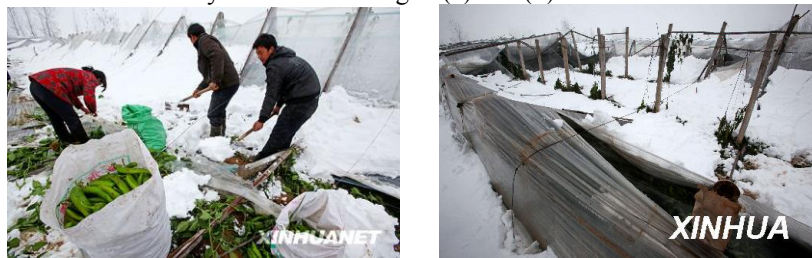
Fig.2. Hua county, He'nan province

(2) On November 10 to 12, 2009, big blizzard has fallen in He'nan province, a lot of anti-season vegetables were damaged by the collapse of sunlight greenhouse under snow load in Hua county. As shown in Fig. 2 (a) and (b).

(6) Distribution form 6: snow was piecewise uniform distribution. The reason is that the horizontal skeleton and vertical purlins were linked together and strong, or the film stiffness and tension was insufficient. So the film sagged under snow load, and formed a separated phenomenon. Fig. 2 (a) and (b) and Fig. 5 (a) all belong to this situation.

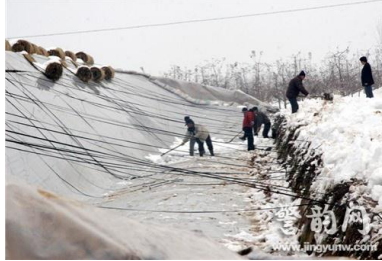
(a) Snow concentrated at the bottom

(4) Distribution form 4: Most of snow slid down, concentrated at the bottom of the slope before greenhouse. Fig. 3 (a) belongs to this situation.

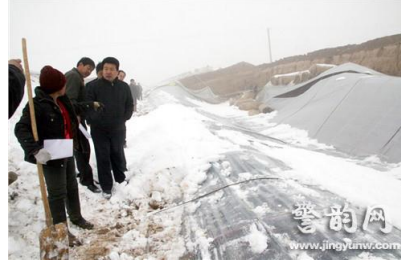
(b) Snow concentrated on the top

(7) Distribution form 7: Most of snow slid down, concentrated at the bottom of the slope before greenhouse. But the roof close to the top was flat, so snow did not slide down. The concentrated force on both ends of the roof finally formed. Fig. 3 (b) belongs to this kind of situation.

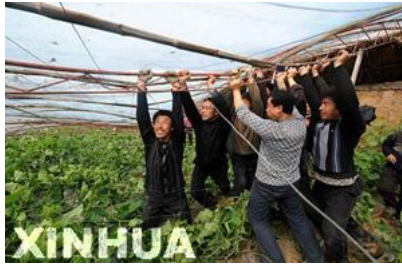
(a) Snow concentrated on the top

(5) Distribution form 5: the snow thickness was biggest in the middle parts of the roof, forwards and backwards gradually reduced. The reason is that the front of the roof was the windward side, so snow moved back in under the action of wind, finally snow stored in relatively flat parts, and made local pressure very big. Fig. 4 (a) and (b) and Fig. 5 (b) all belong to this situation.

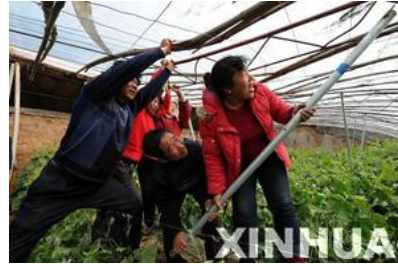
(b) Snow concentrated on the top

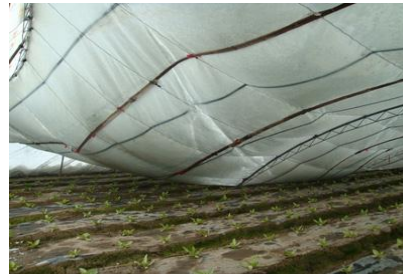
Fig.5. Yumen,Gansu province

(a) Snow piecewise uniform distribution (b) Snow concentrated on the top

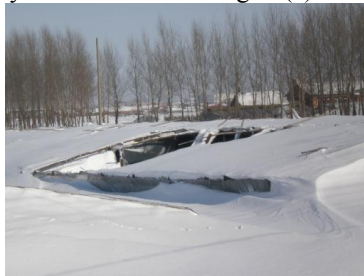
(a) Snow uniform distribution

(1) Distribution form 1: snow was uniform distribution, because the roof slope was slow, what was more, the front and back of roof slope were similar, and there was no wind or wind was small when snowed. Fig. 6 (a) and (b) both belong to this situation.

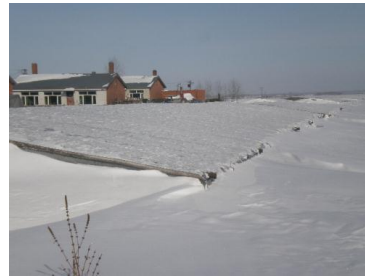
(b) Snow uniform distribution

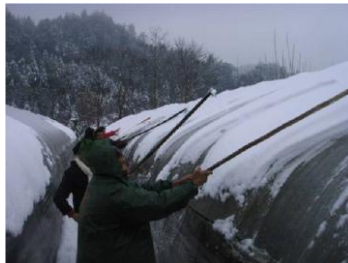
Fig.7. Wanzai, Jiangxi province

(7) On 18-20 January, 2011, after three days of consecutive heavy snow, a lot of greenhouse vegetables were under different degree of loss in Wanzai county, Yichun city, Jiangxi province. According to preliminary statistics, more than 1500 greenhouses were affected, including more than 1100 bamboo greenhouses and more than 400 steel greenhouses, the direct economic loss was up to more than 3 million yuan. As shown in Fig. 7.

(2) Distribution form 2: snow was uniform distribution, just because the front and back of roof slope were large different, so the thickness of snow. The back of the roof slope was steep, so snow was easy to slide down, snow thickness is very small. The front of the roof slope was slow, so snow thickness is very big. Fig. 7 belongs to this situation.

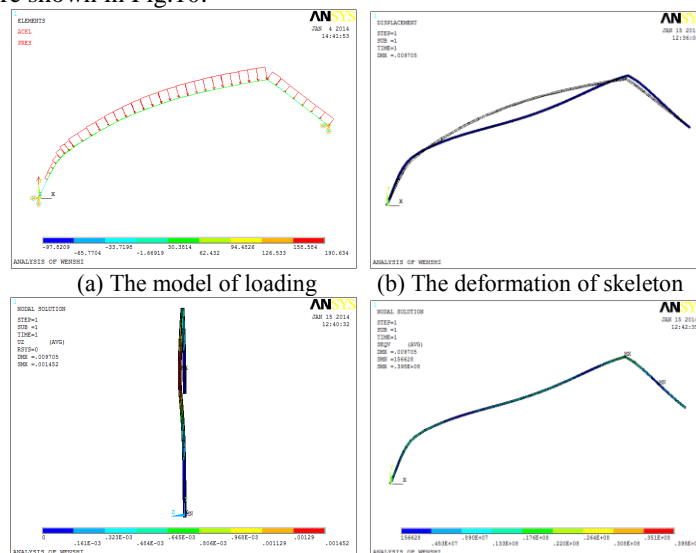
According to the load model, calculate the results by using ANSYS finite element software. For example, in standard condition, the start loading position was on that the angle between tangent of the curve and the horizontal was 60° , in other words, load from number 4 node, The length of the load was 7.76 m. Results of mechanical analysis were shown in Fig.10.

(c) The out-of-plane displacement of skeleton (d) Stress of skeleton

Fig.10. Results of mechanical analysis

As the stress nephogram and deformation pattern above shown, the maximum stress was 39.5MPa, the position was on the outer edge of the skeleton near vault point (position: near node 33); the maximum displacement of whole structure was 9.7 mm (position: near node 22), the maximum out-of-plane displacement of whole structure (UZ) was 1.5 mm (position: near node 22).
