Surface Distresses Detection of Pavement Based on Digital Image Processing

Aiguo Ouyang, Chagen Luo, Chao Zhou

Aiguo Ouyang, Chagen Luo, Chao Zhou. Surface Distresses Detection of Pavement Based on Digital Image Processing. 4th Conference on Computer and Computing Technologies in Agriculture (CCTA), Oct 2010, Nanchang, China. pp.368-375, 10.1007/978-3-642-18369-0_42 . hal-01564843

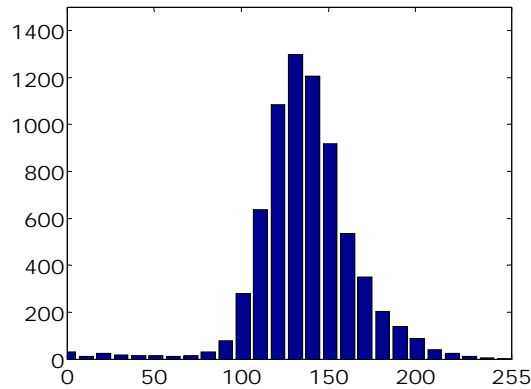
Fig. 10. Histogram of original image.

Image segmentation is the crucial step in automatic image distress detection and classification (e.g., types and severities) and has important applications for automatic crack sealing [13]. The segmentation approach chosen was based on a histogram modification technique. This histogram modification was achieved through iterative clipping. At each stage in iterative clipping, more pixels were assigned to the background. This process continues until only distress features were left. The end result as shown in Figure 12 was an image in which the distresses were distinct and easily separable from the background. At this point, a threshold value could be determined automatically in order to isolate the distress features from the background. Transformation function in Figure 11 presented that the threshold value was near 0.6.

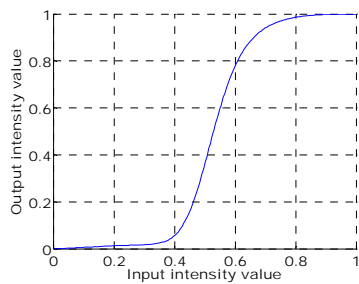
Fig. 11. Transformation function.

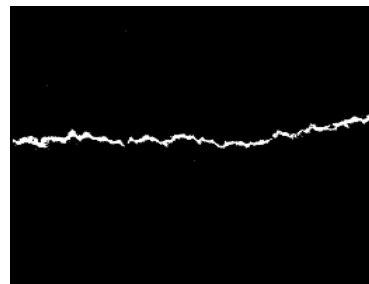
Fig. 12. Result of histogram modification.

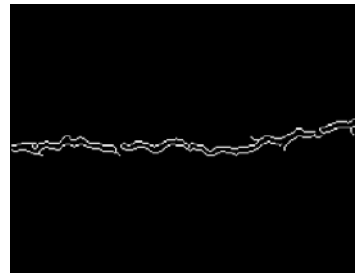
Fig. 14. Threshold value=0.5.

gradients were calculated to determine edge points. Using two threshold values 0.5 and 0.4, different correlated edge points were linked together. The strength of the method is its ability to detect edges in the presence of noise and to detect weak edges. Preliminary results from canny edge detection in figure 14~16 showed that the optimum identification of distress was dependent on the parameters used in the algorithm and that the optimum parameters varied with each image. There was a problem of coming up with false distress boundaries when a very high standard deviation in Gaussian filtering was used. The distress may seem wider than it actually was resulting in false severity level detection.

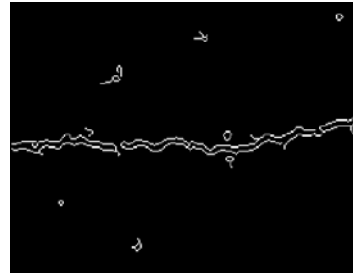
Fig. 16. Result of canny edge detection.
